APPENDIX A  
PHOTOGRAPHS AND SKETCHES

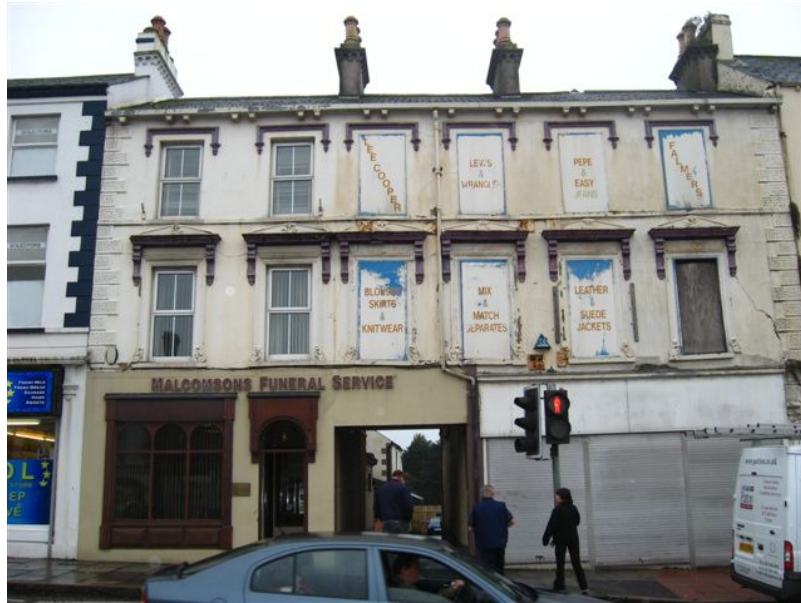
Photo 1 – Front Elevation

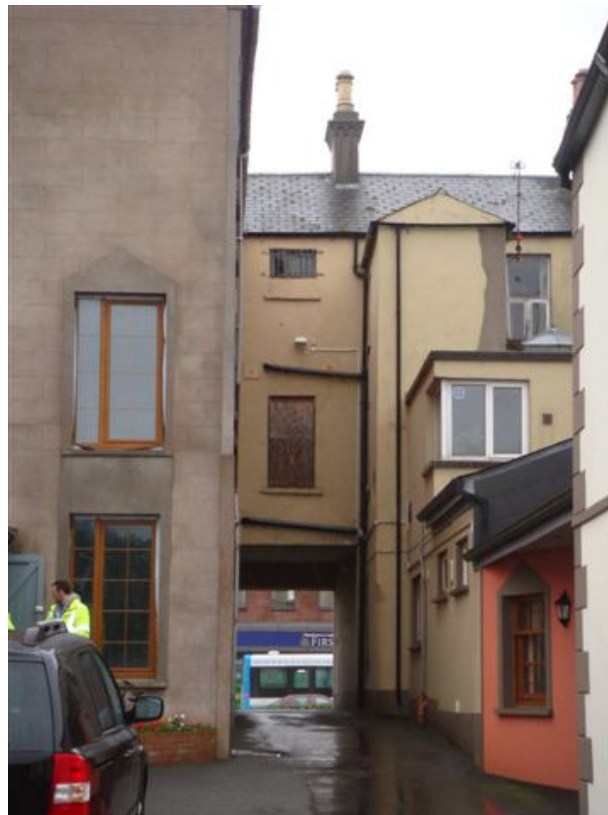
Photo 2 – Rear Elevation

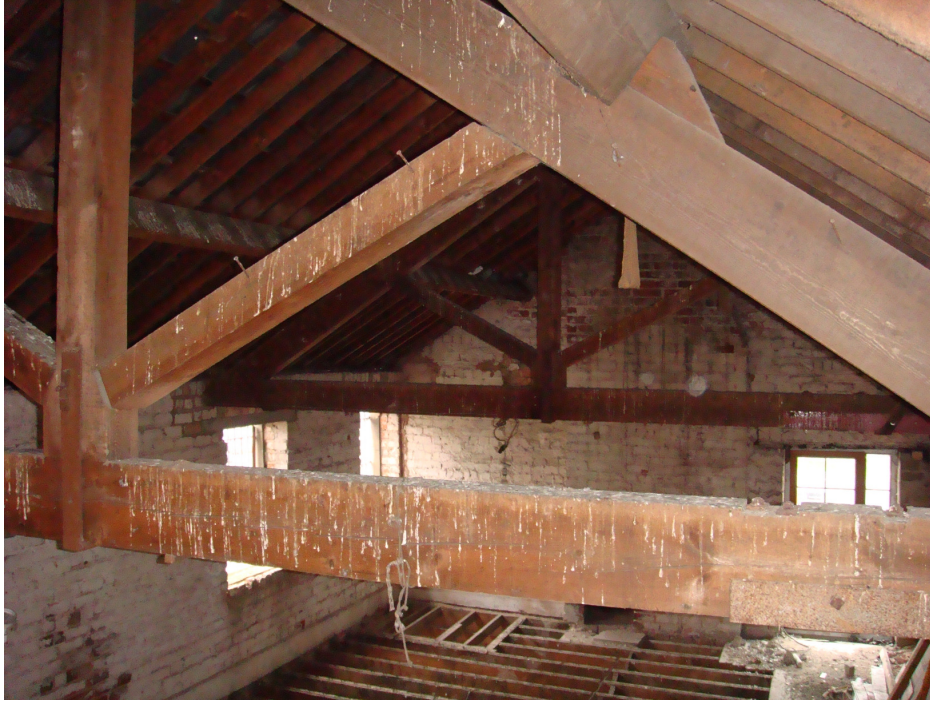
Photo 3 – Extension Roof Layout

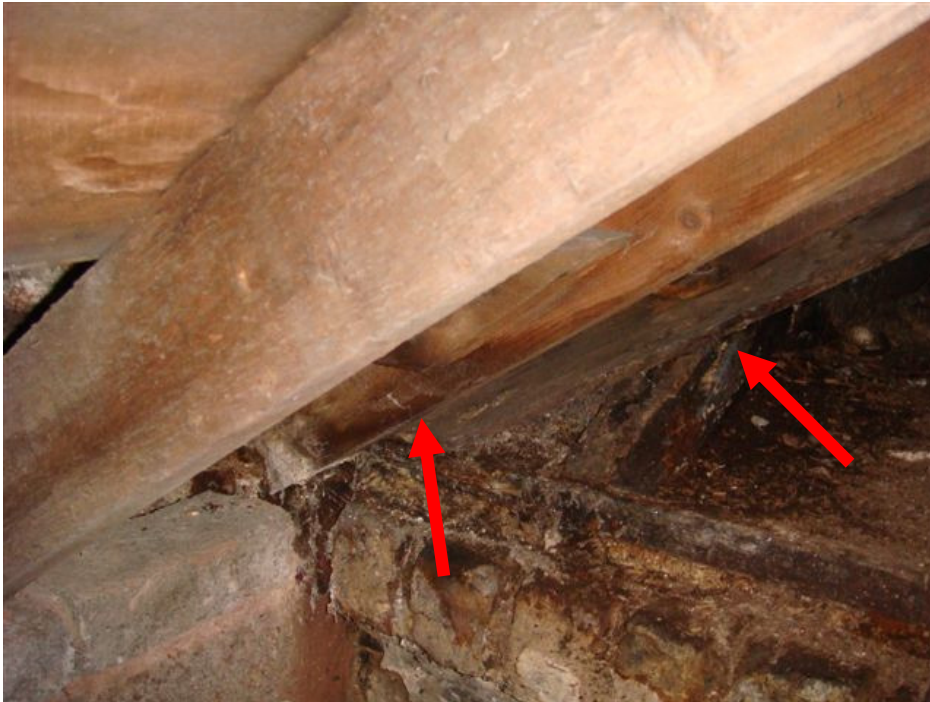
Photo 4 – Damp and rot in the existing building rafters

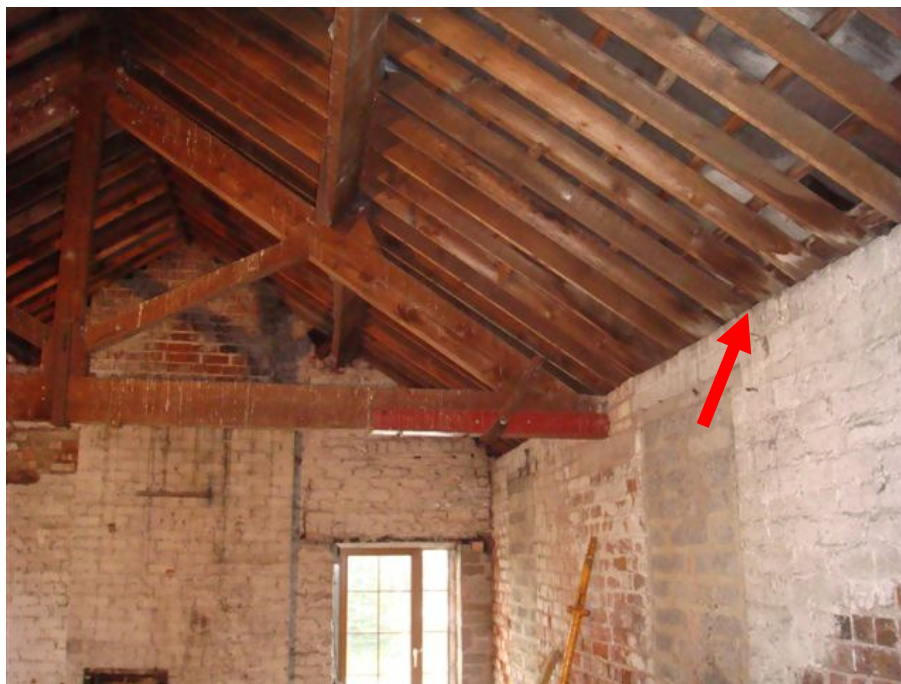
Photo 5 – Damp and rot at rafter support on party wall

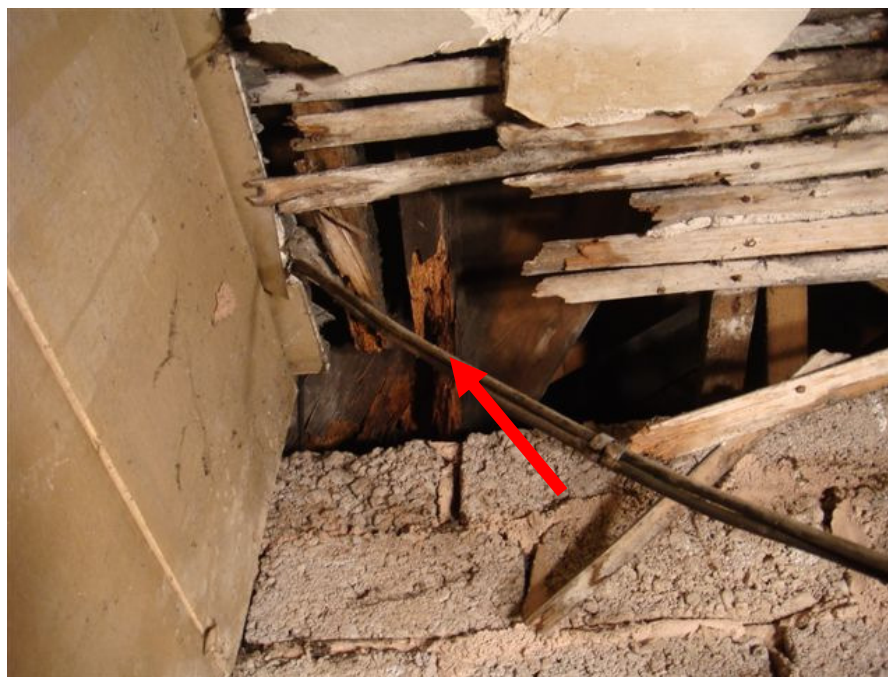
Photo 6 – Damp and rot in existing building rafters at intermediate wall location

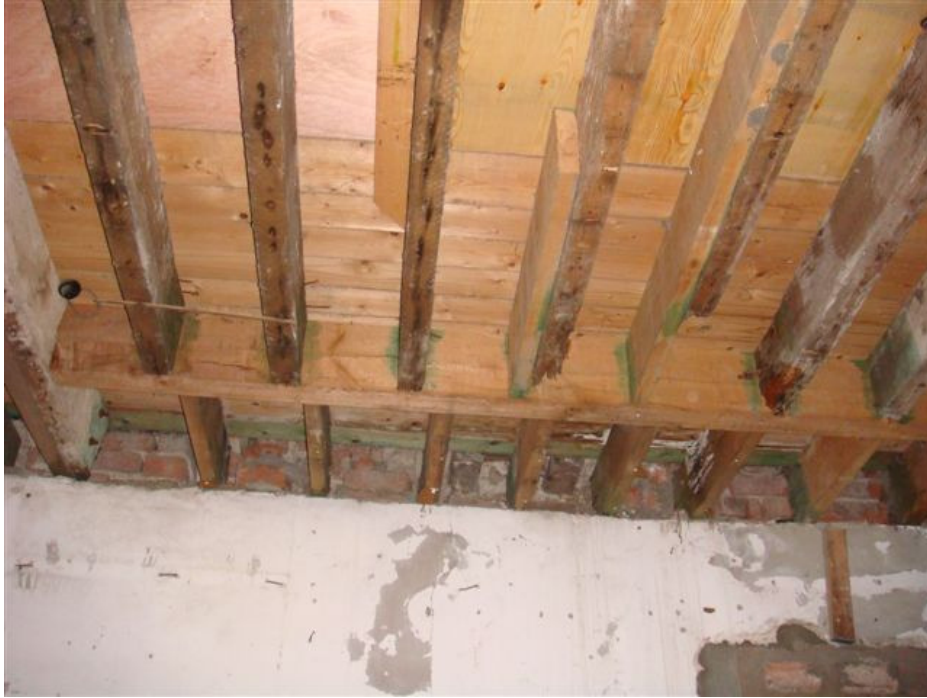
Photo 7A – 2<sup>nd</sup> floor joists cut & spliced on binder

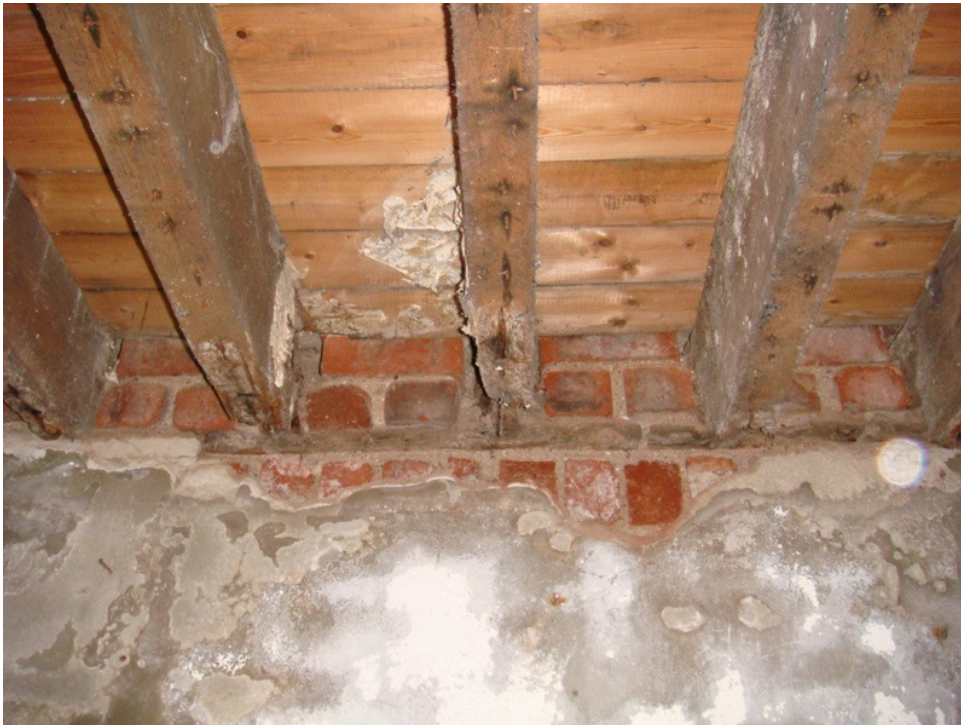
Photo 7B – Damp & rot in 2<sup>nd</sup> floor joists along the party wall

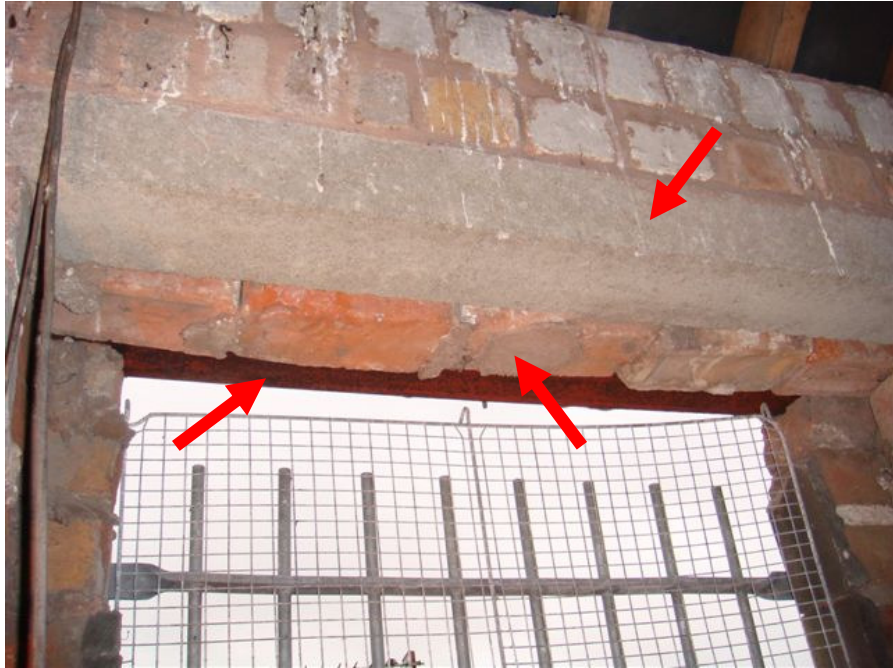
Photo 8 – Intermediate brick leaf unsupported

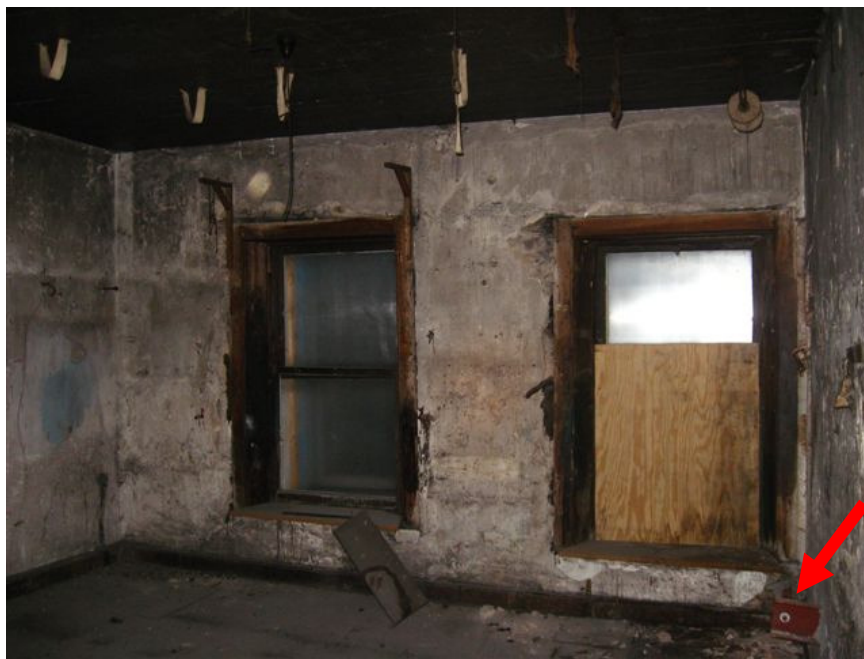
Photo 9 – 2<sup>nd</sup> Floor bedroom 2 tie rod

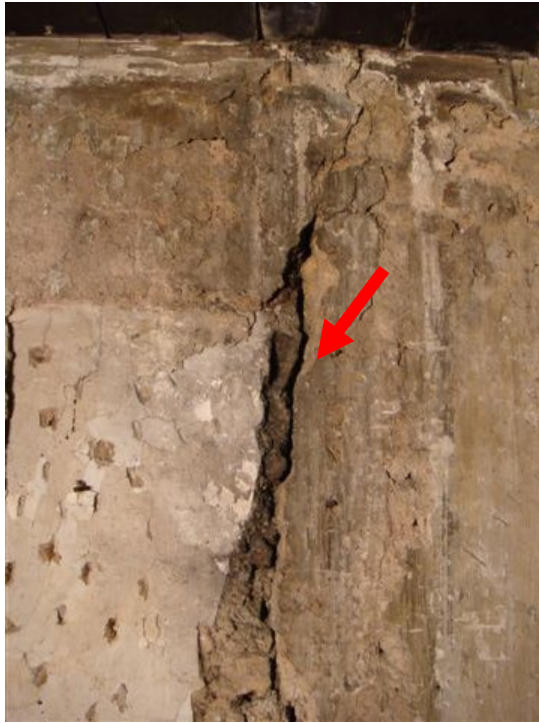
Photo 10 – Vertical crack approximately 5mm wide to LHS of chimney breast

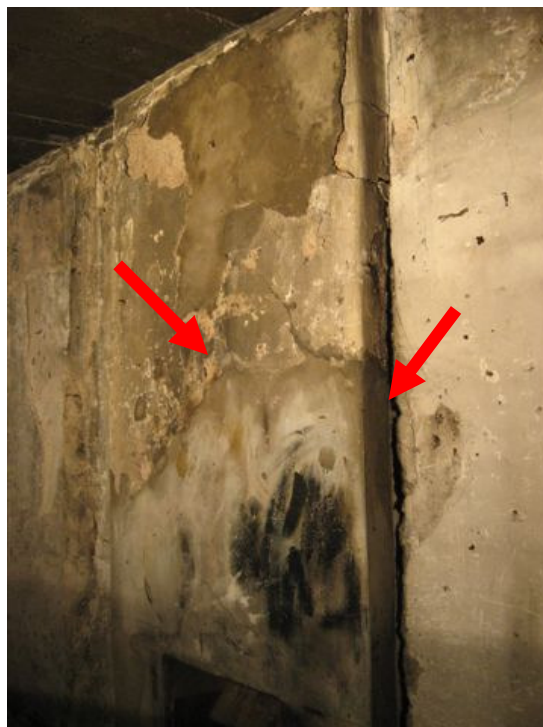
Photo 11 – Chimney breast moving away from party wall

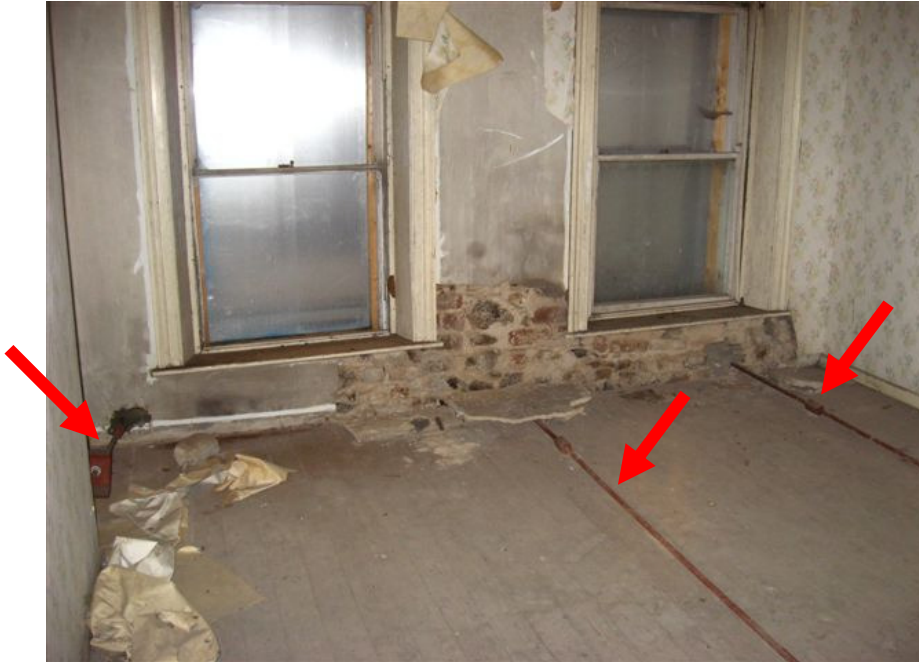
Photo 12 – 2<sup>nd</sup> Floor bedroom 1 tie rods

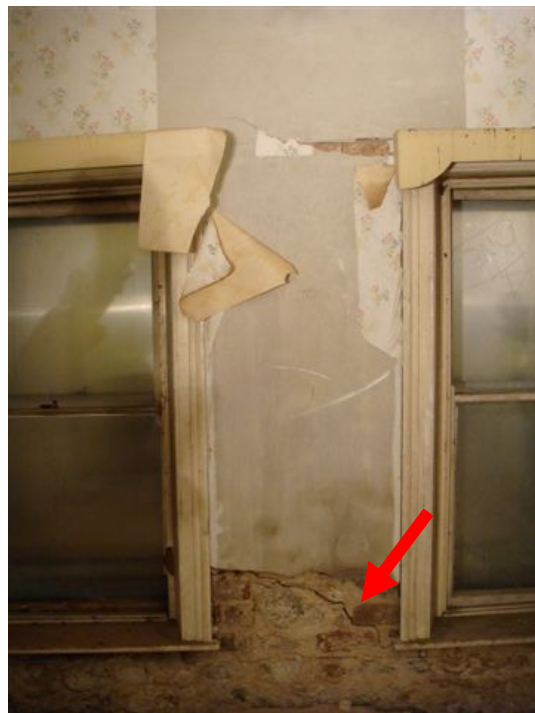
Photo 13 – Diagonal crack approx. 3-4mm wide between windows

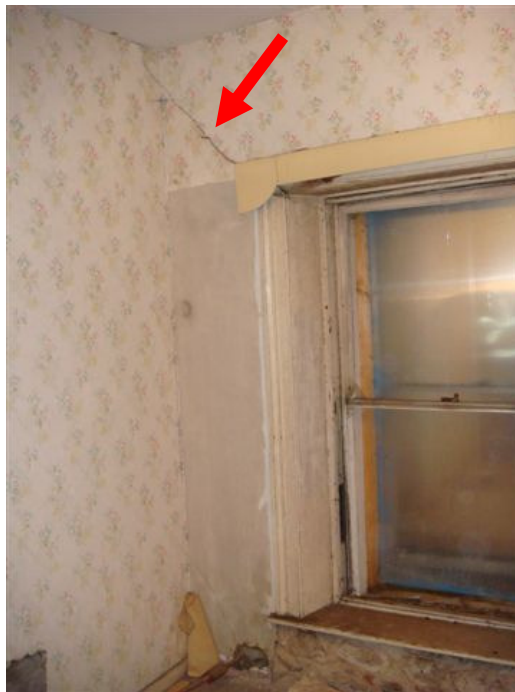
Photo 14 – Diagonal crack above window

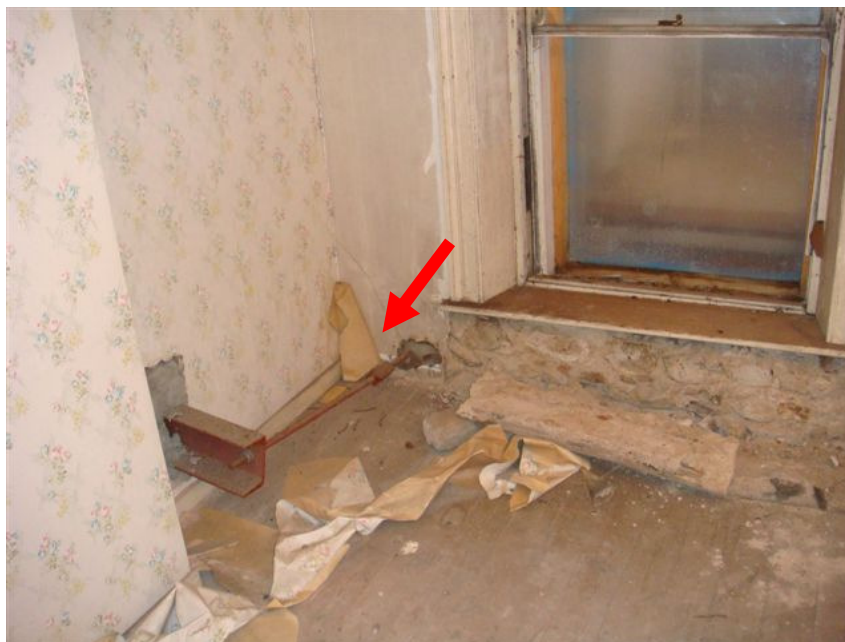
Photo 15 – Diagonal crack above the tie rod

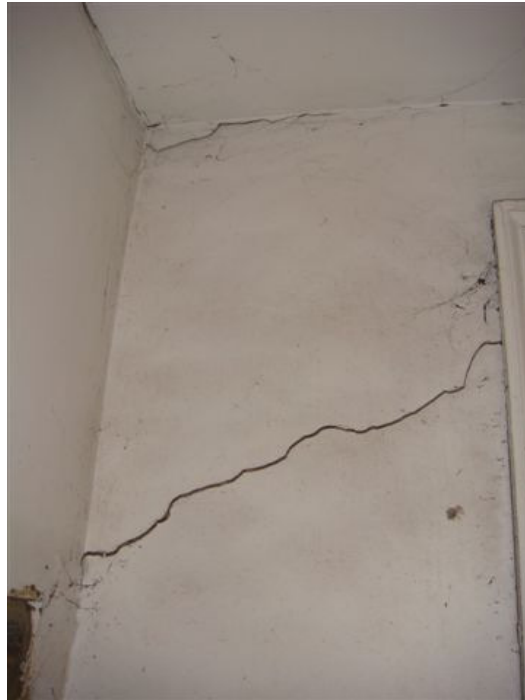
Photo 16 – Diagonal crack approx. 3-4mm wide

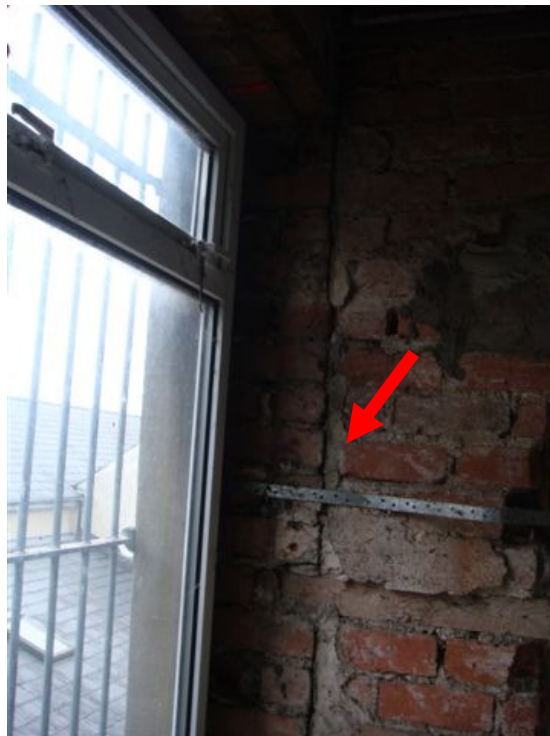
Photo 17 – Extension corner wall junction.

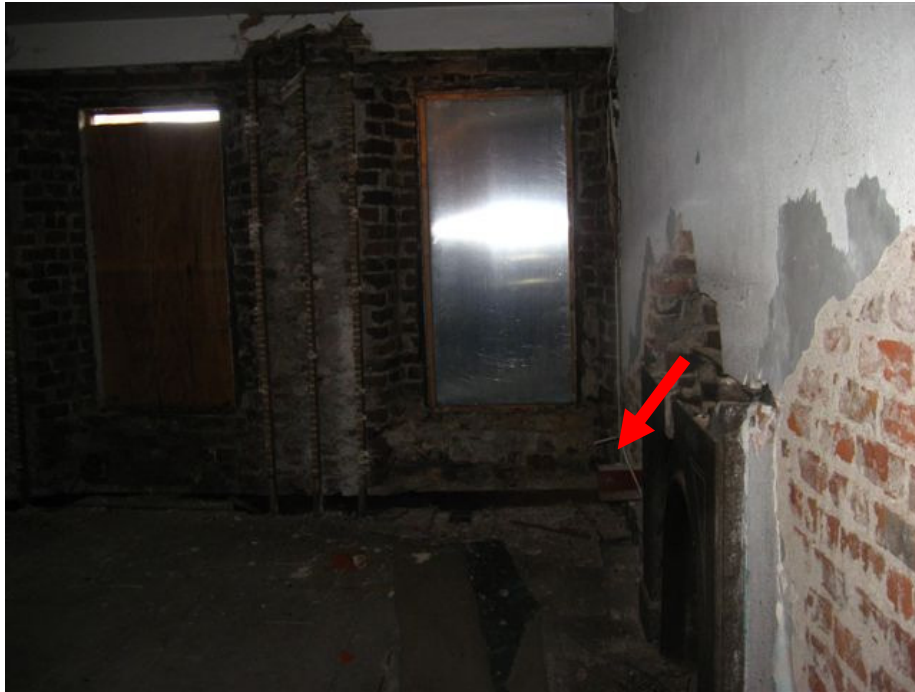
Photo 18 – 1<sup>st</sup> Floor right side room tie rod

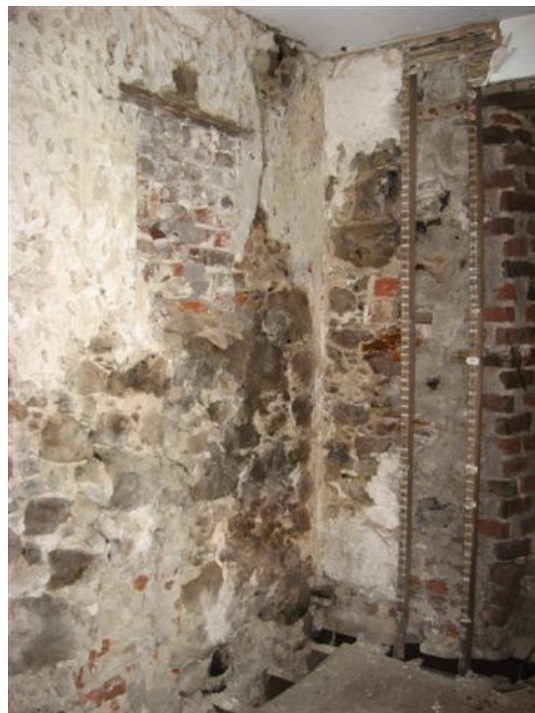
Photo 19A – Party wall between property numbers 1 & 3.

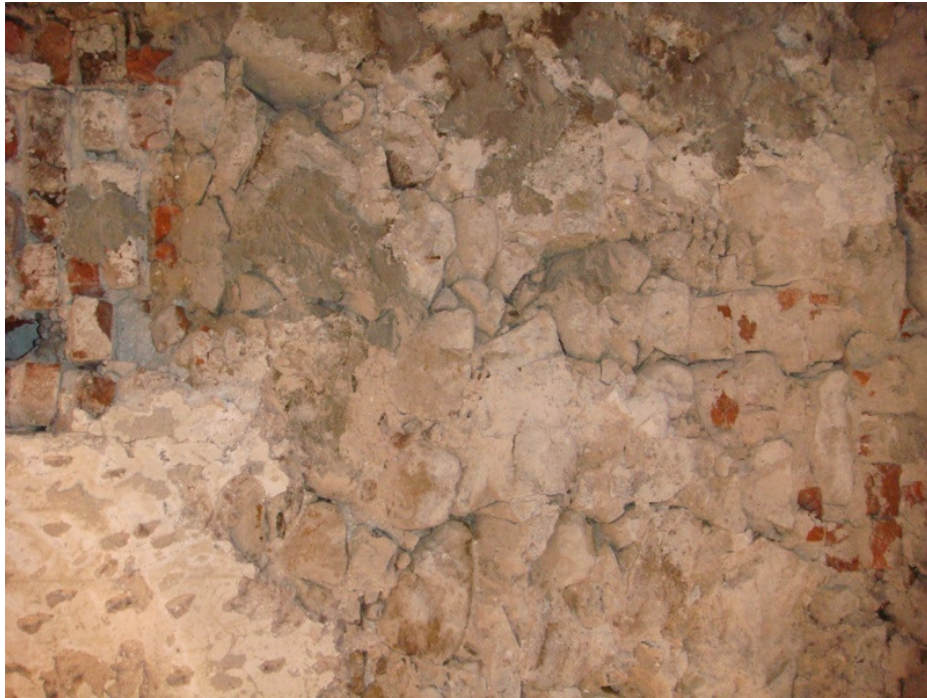
Photo 19B – Random nature of party wall between property numbers 1 & 3.

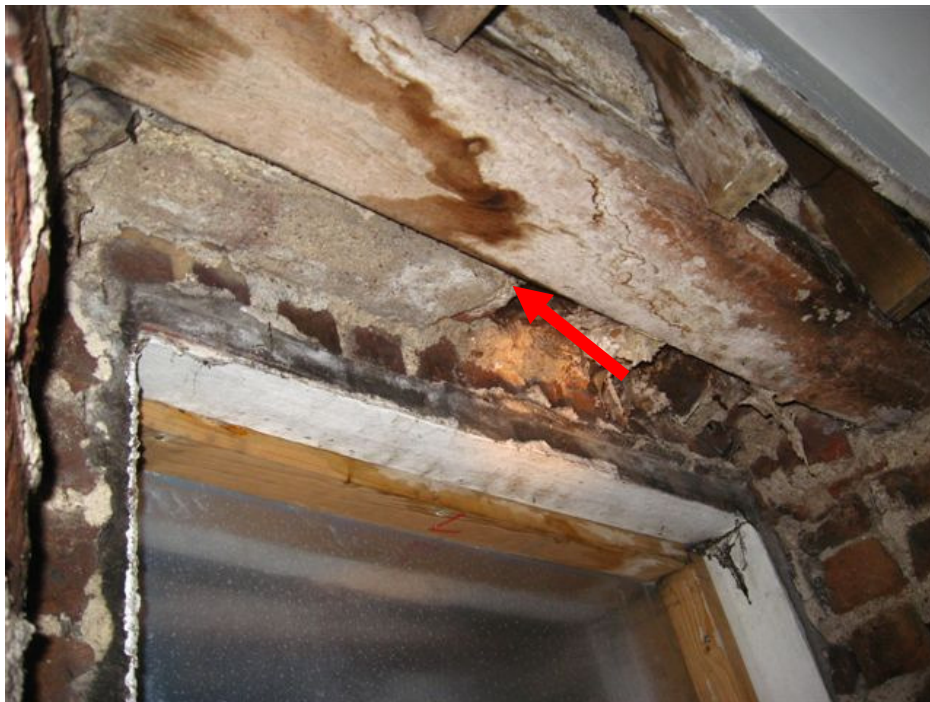
Photo 20 – Front façade – middle leaf not supported & decayed head

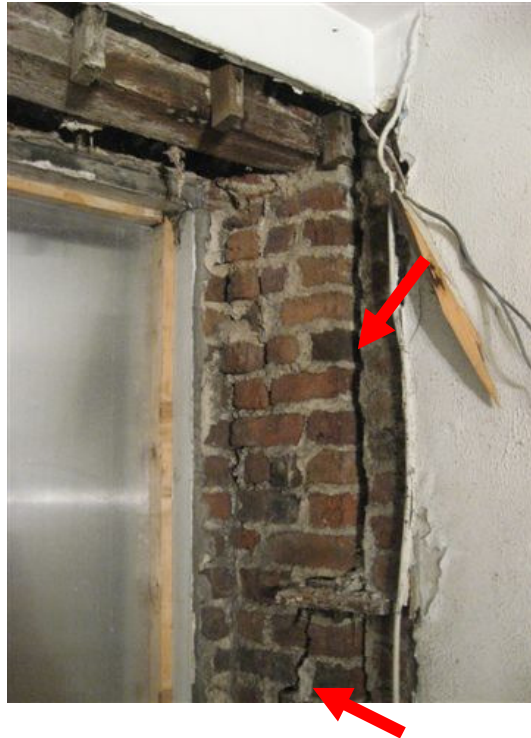
Photo 21A – Gap between intermediate wall and front façade. Diagonal crack in the reveal approx 4-5mm wide.

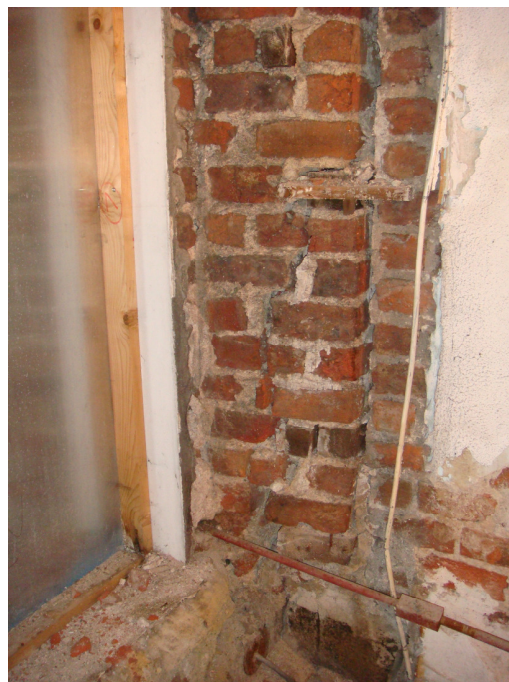
Photo 21B – Gap between intermediate wall and front façade. Diagonal crack in the reveal approx 4-5mm wide.

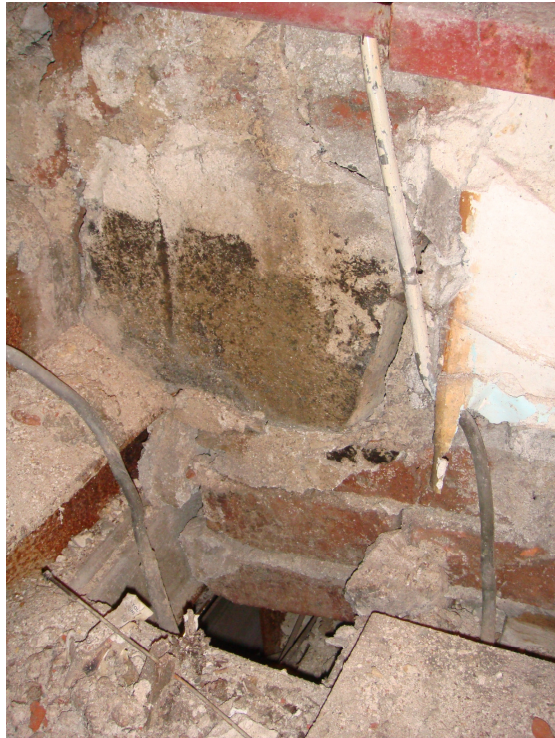
Photo 21C – Evidence of downward movement of intermediate wall relative to facade

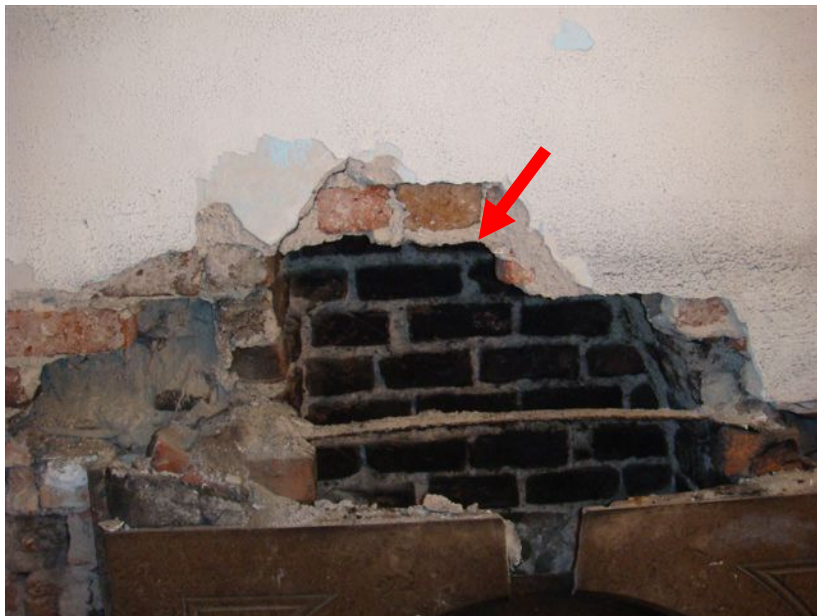
Photo 22 – Disruption in masonry over chimney breast

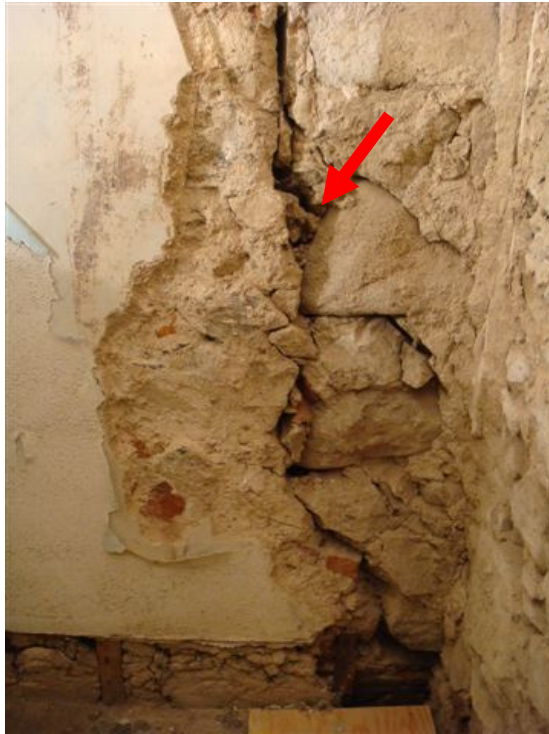
Photo 23 – Vertical crack in the original rear wall

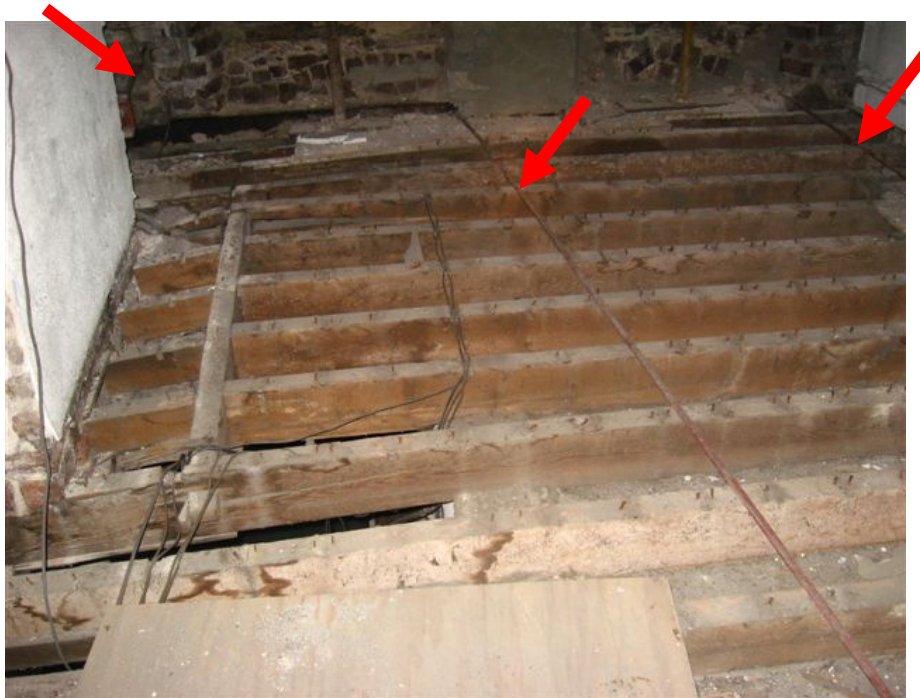
Photo 24 – 1<sup>st</sup> Floor front left side room tie rods & disruption to floor joists

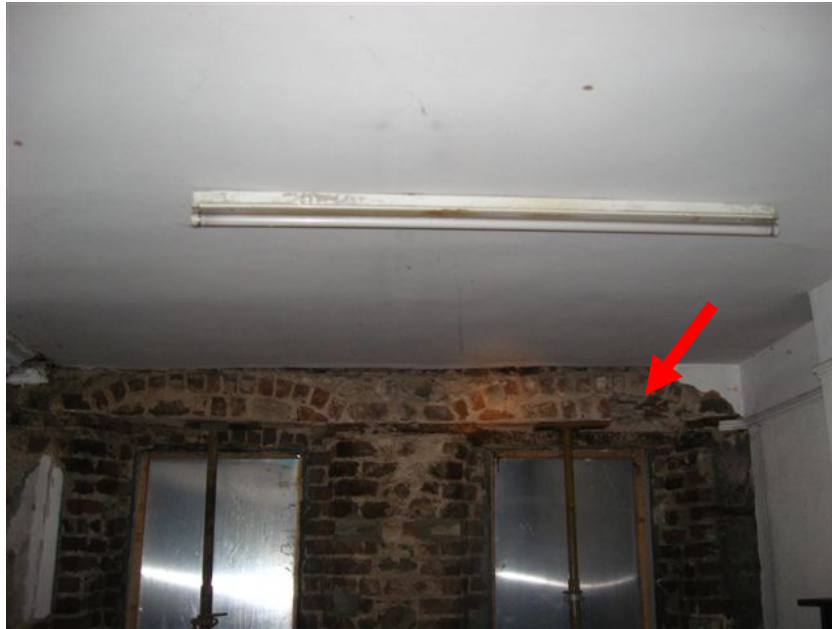
Photo 25A – Missing brickwork at RHS window where additional prop was installed.

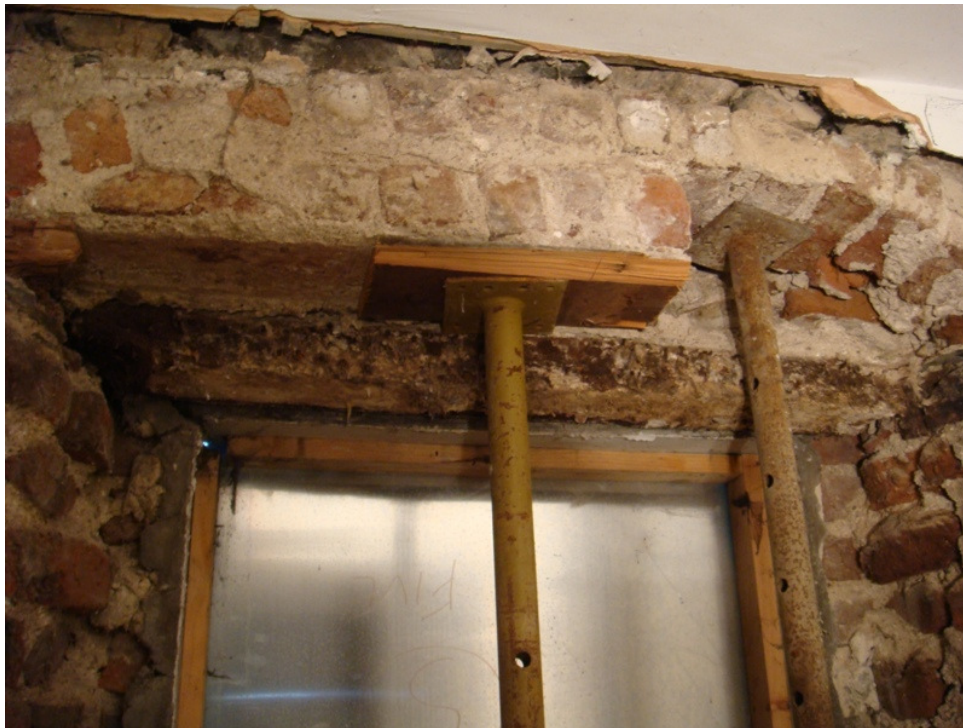
Photo 25B – Missing brickwork at right side window & complete loss of timber head

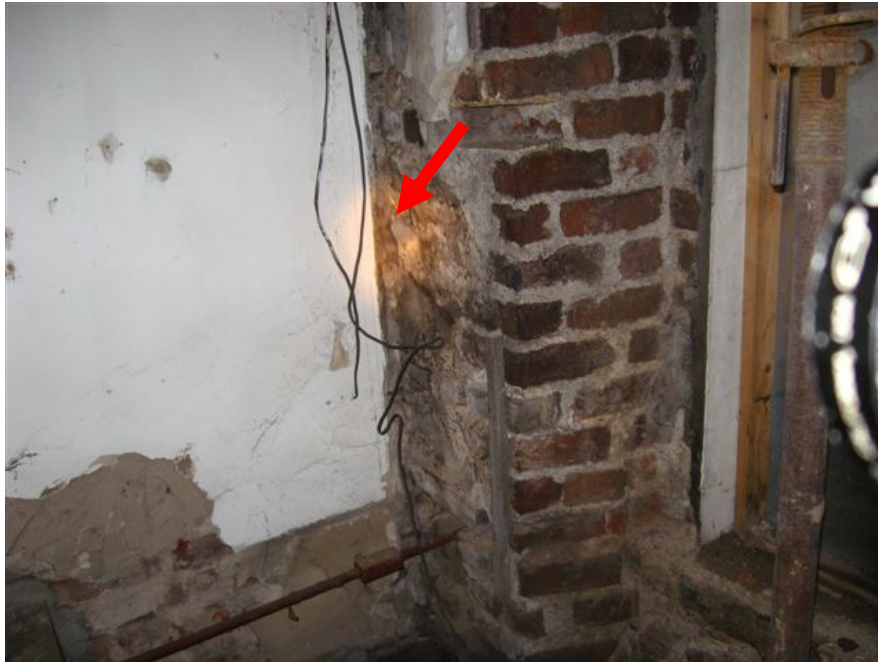
Photo 26A – Gap between intermediate wall and the front façade

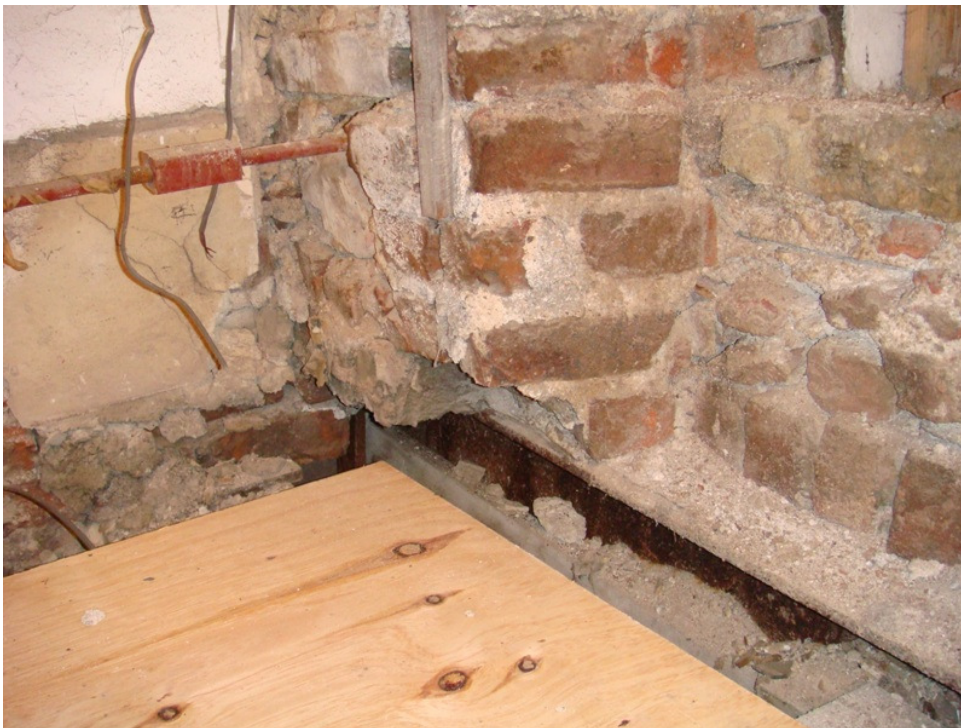
Photo 26B – Erosion of support to masonry at window reveal

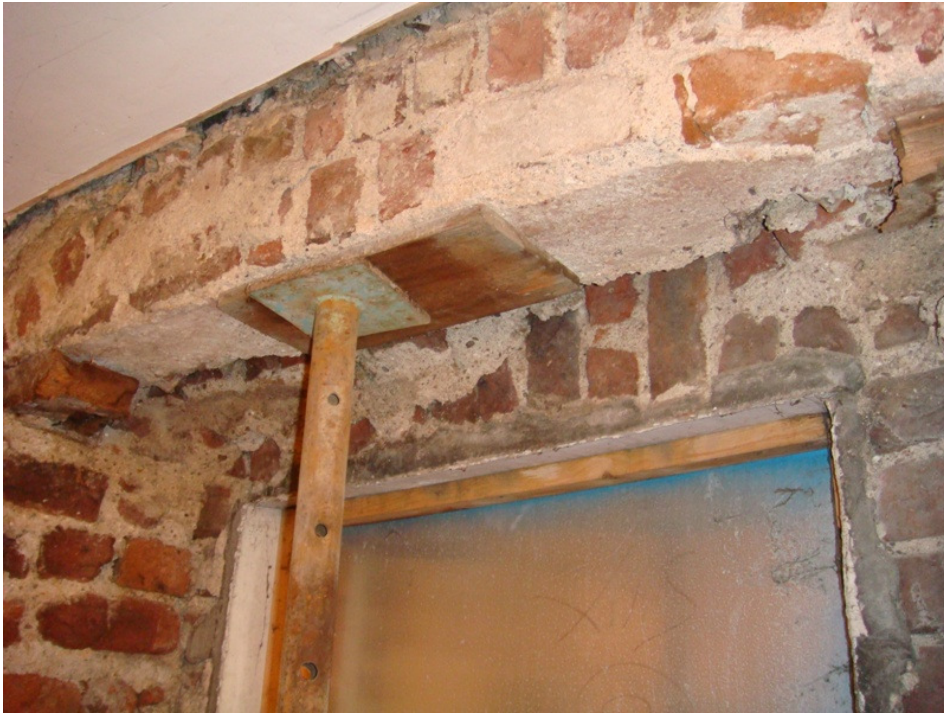
Photo 26B – Complete loss of timber head

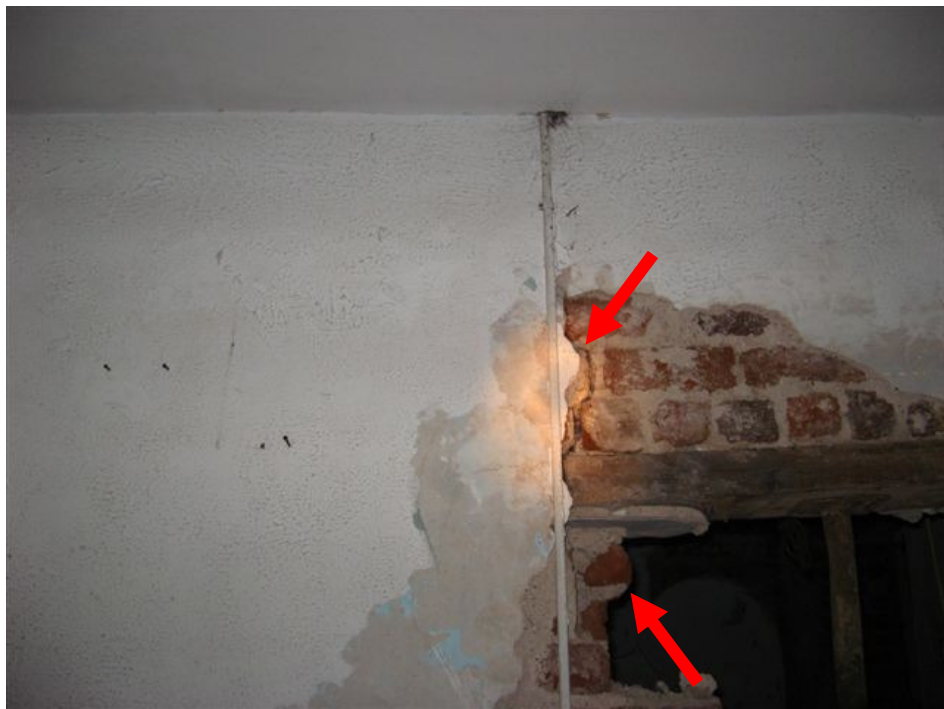
Photo 27 - Vertical crack over doorway in the intermediate wall and damaged reveal

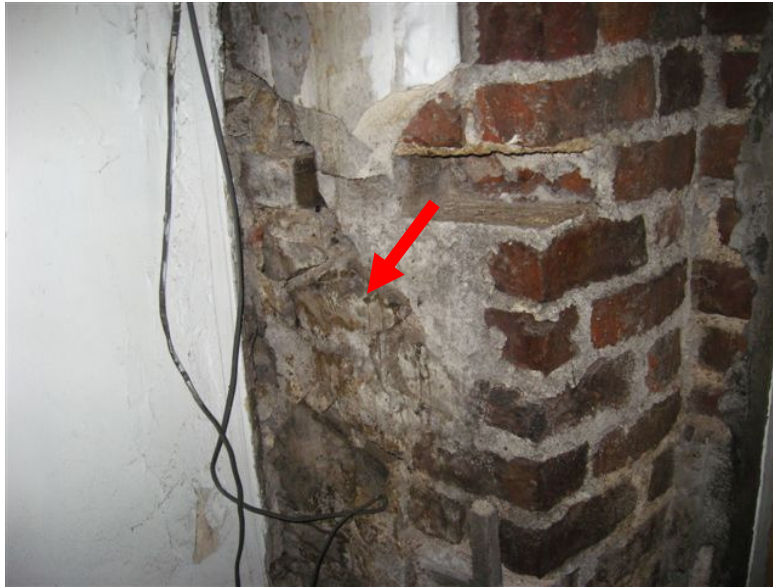
Photo 28 – Diagonal shear cracking in wall above the tension ties.

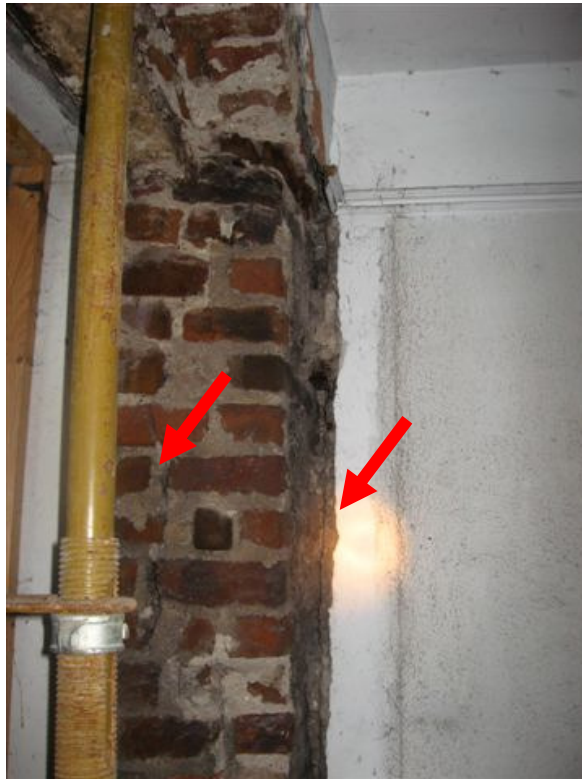
Photo 29A – Vertical crack at junction of party wall between property number 3&5 and vertical crack in front wall right window opening.

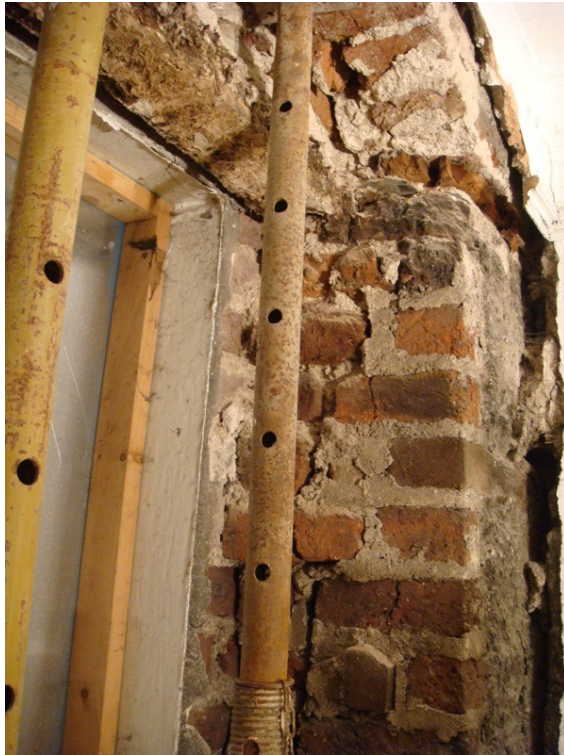
Photo 29B – Disruption to masonry at head and reveal of window

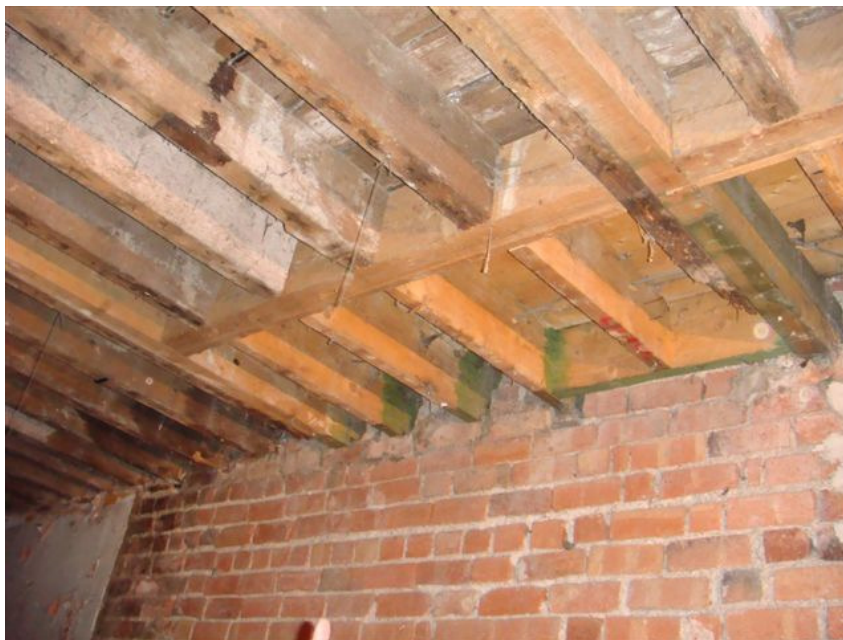
Photo 30 – 1<sup>st</sup> Floor joists cut & spliced with binder

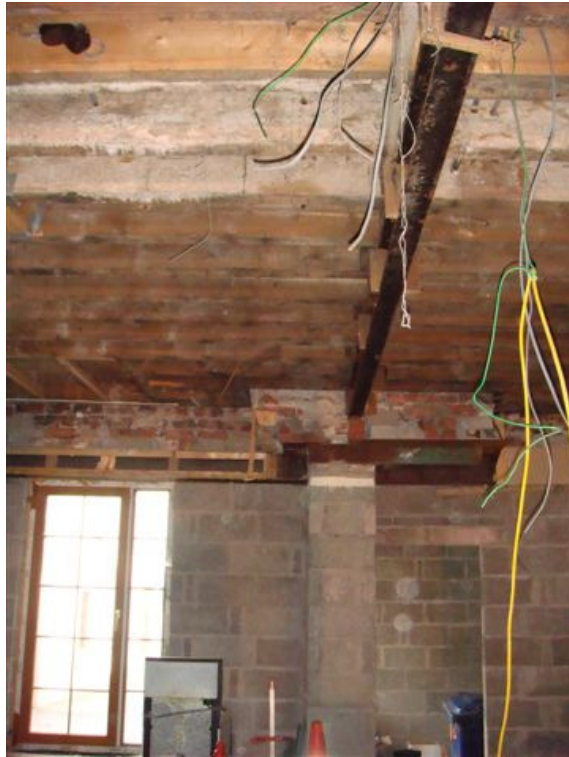
Photo 31 – 1<sup>st</sup> floor steel beam support

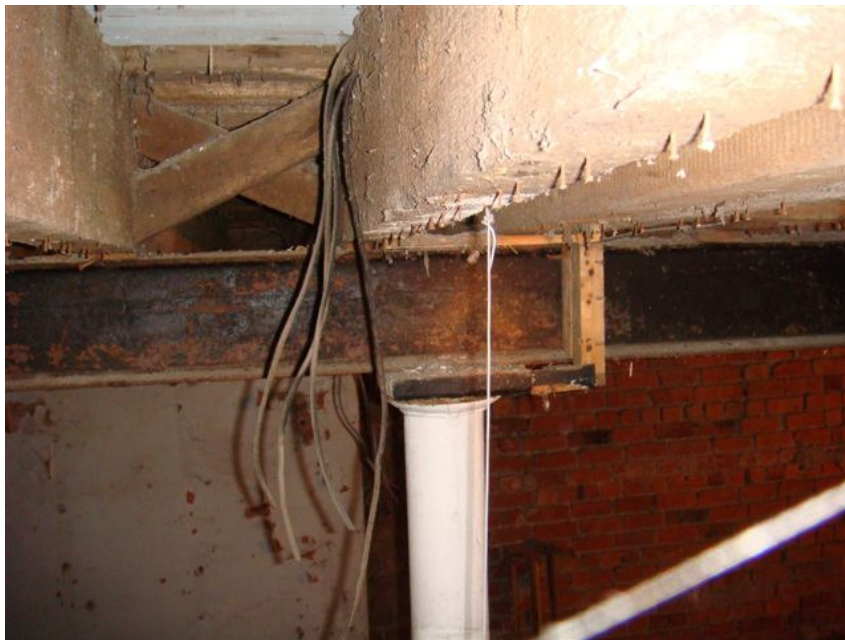
Photo 32 – Post support of the 1<sup>st</sup> floor steel beam

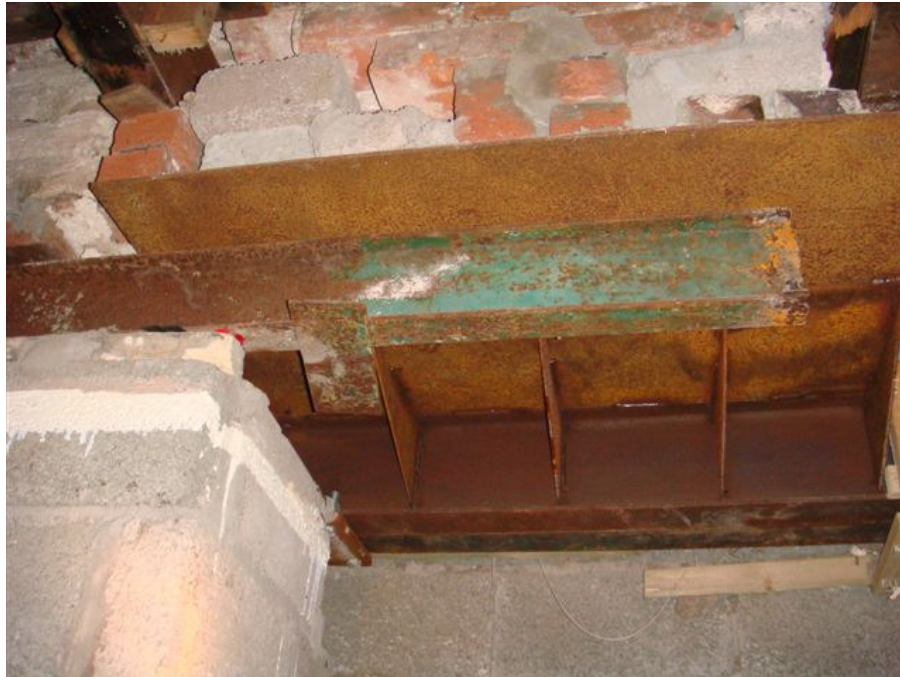
Photo 33 – Support arrangement for rear chimney

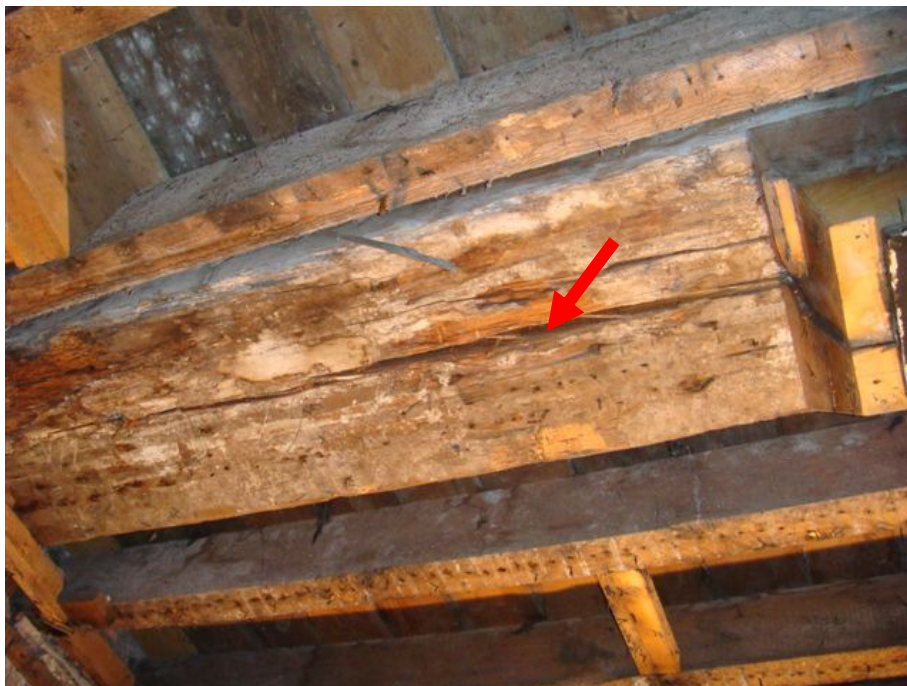
Photo 34A – Split in timber beam supporting original rear wall.
