APPENDIX A  
PHOTOGRAPHS AND SKETCHES

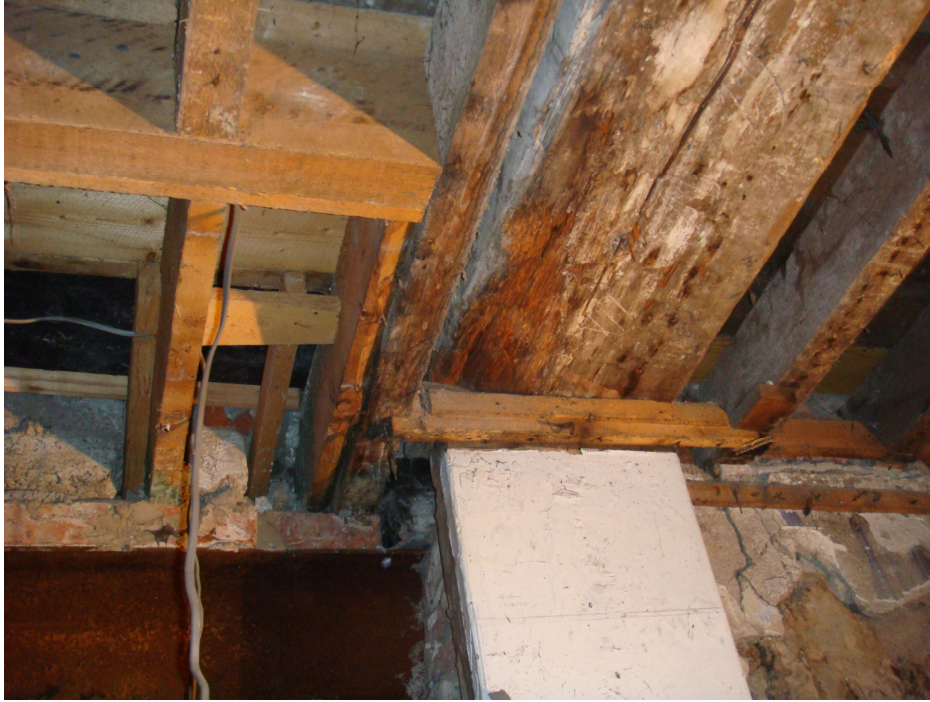
Photo 34B – Rot to end of timber beam at support

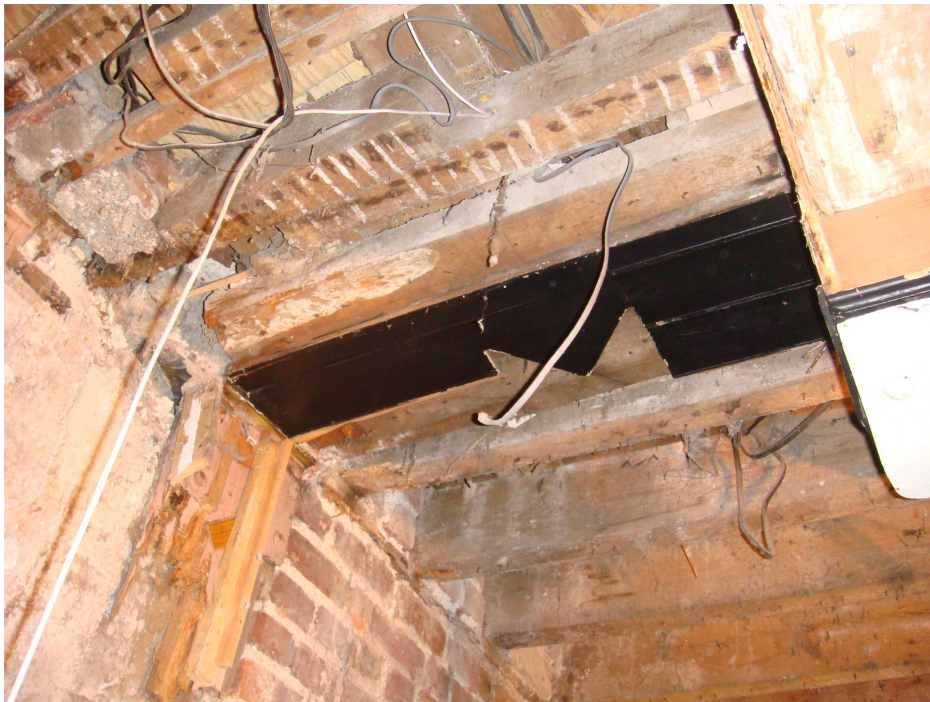
Photo 34C – Rot to end of timber beam at external wall to alley

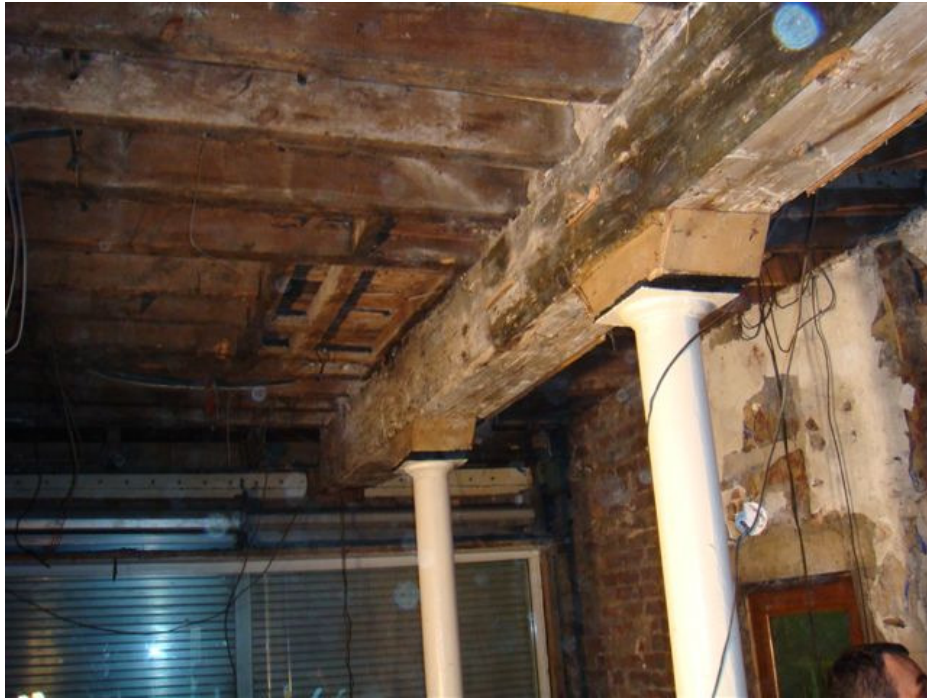
Photo 35A – Timber beam support for the intermediate wall

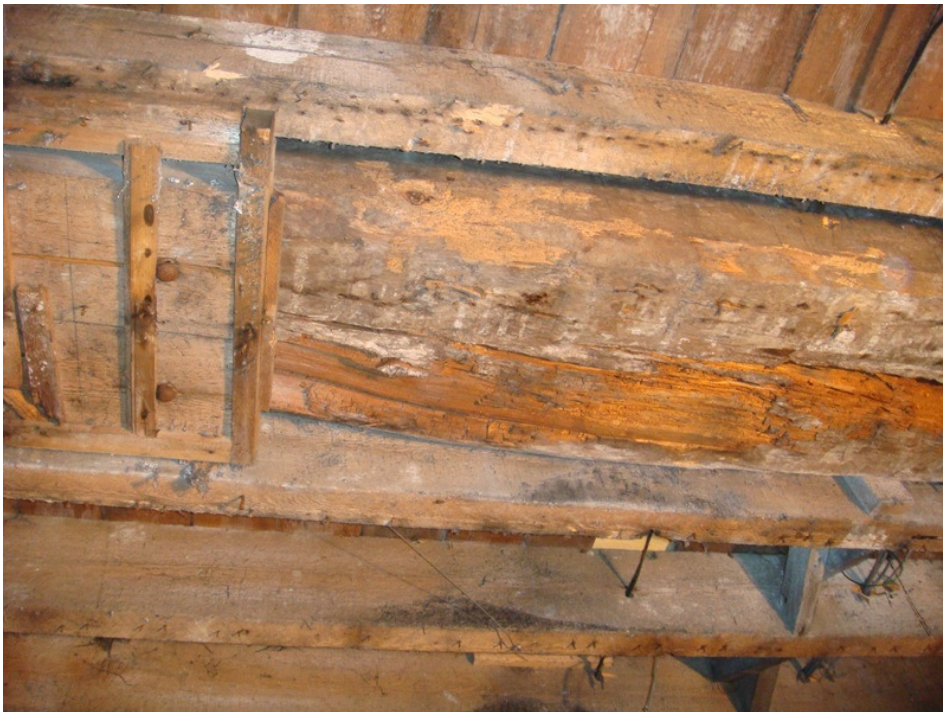
Photo 35B – Rot to underside of timber support beam

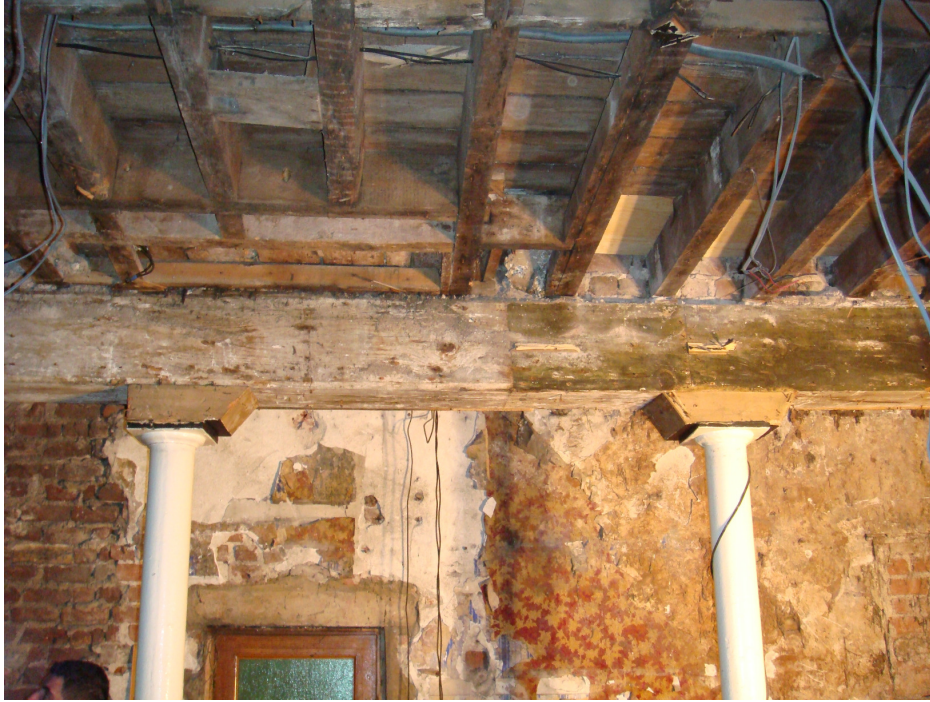
Photo 36A – Timber beam supporting the intermediate wall.

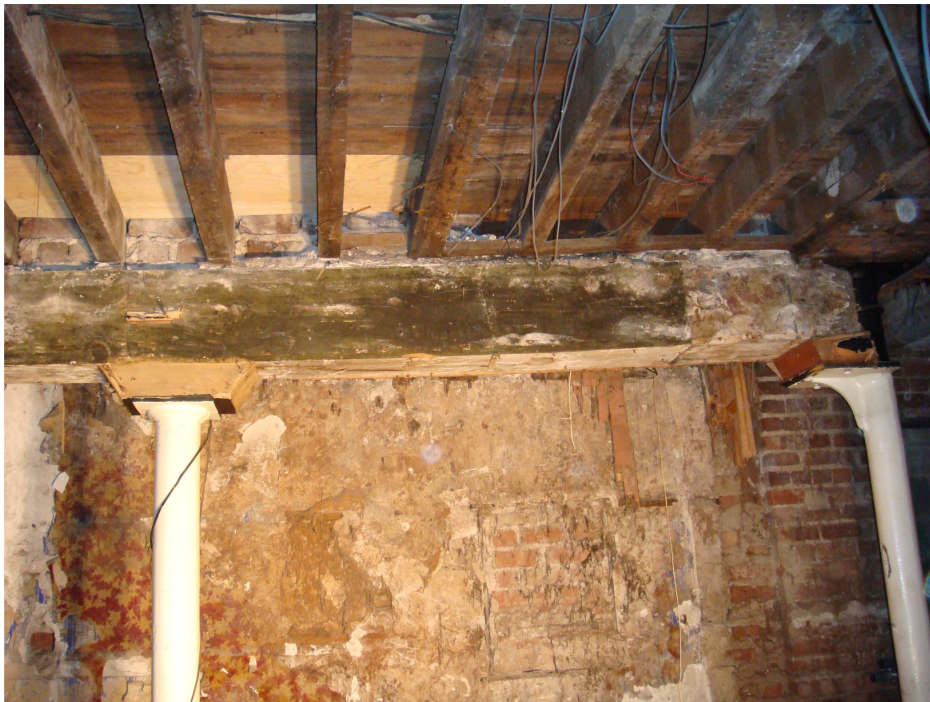
Photo 36B – Deflection in timber beam and rotation of support

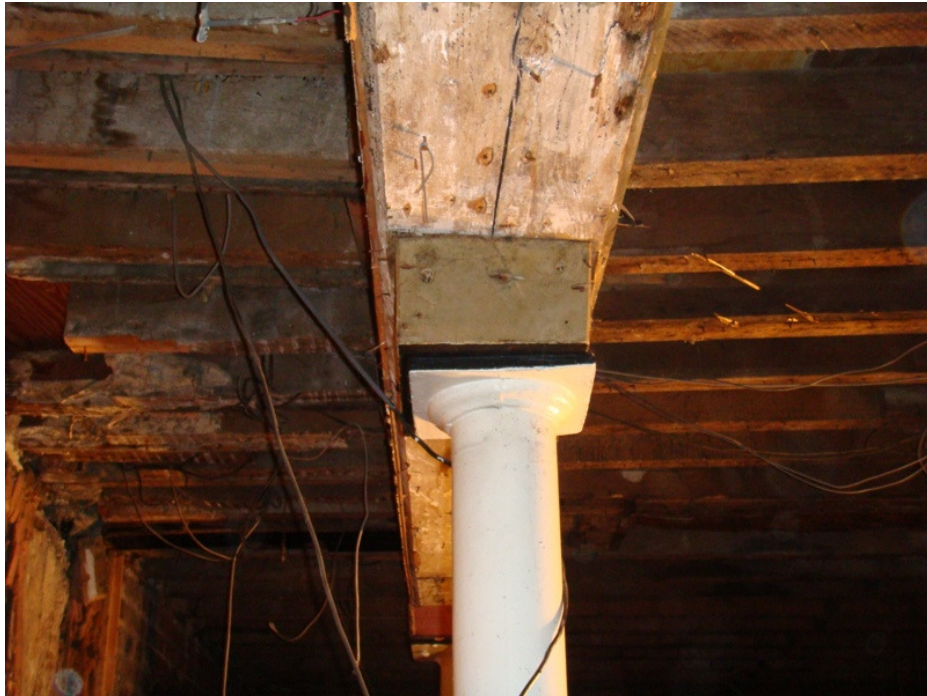
Photo 36C – Decay in adjacent joists and poor support alignment

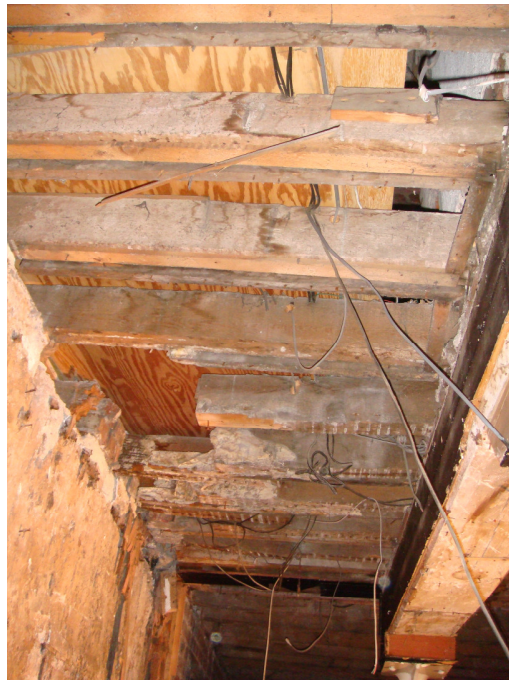
Photo 36D – Close up of decay and disruption to joists

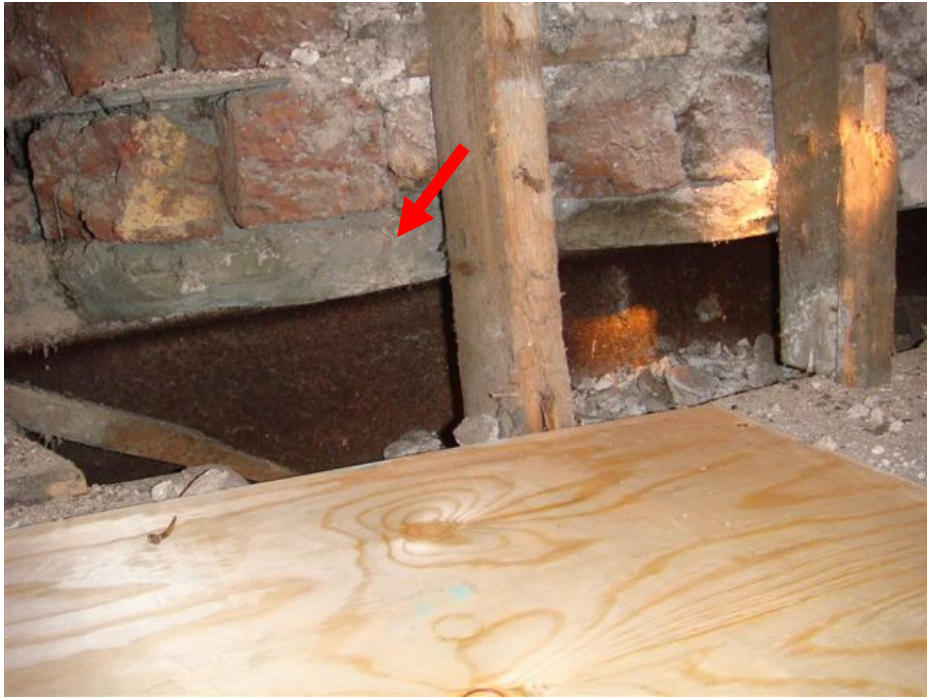
Photo 37A - Steel beam / wall support arrangement along front façade

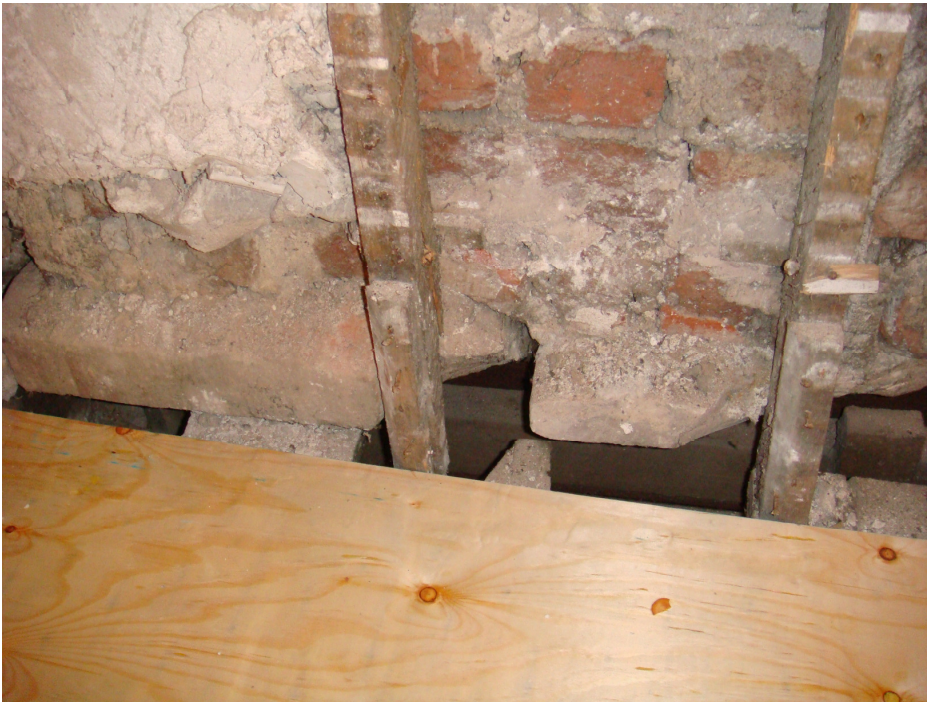
Photo 37B - Steel beam / wall support arrangement along front façade

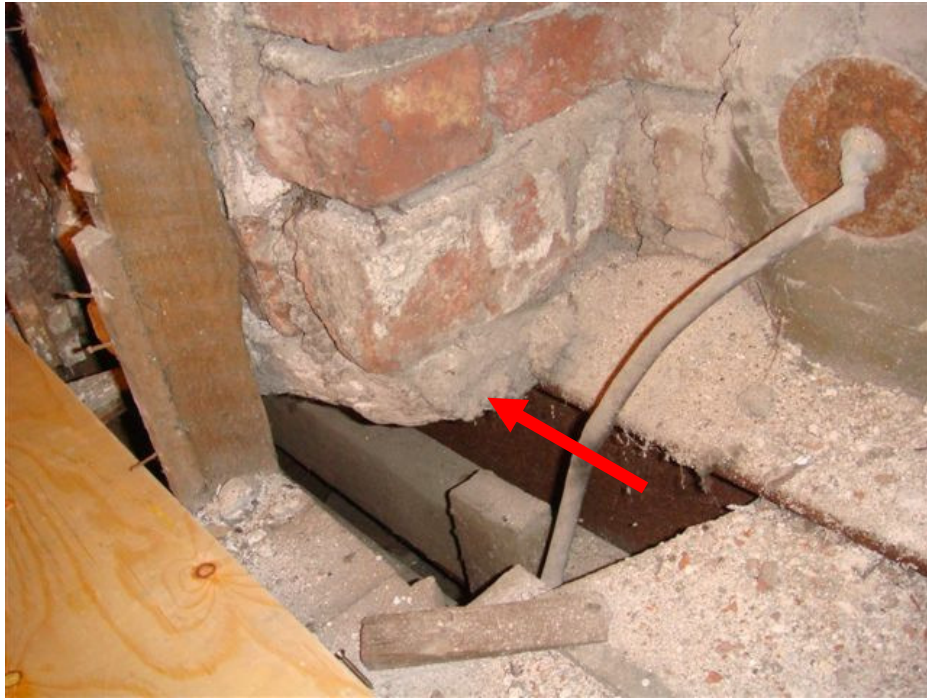
Photo 38 - Steel beam / wall support arrangement along front façade

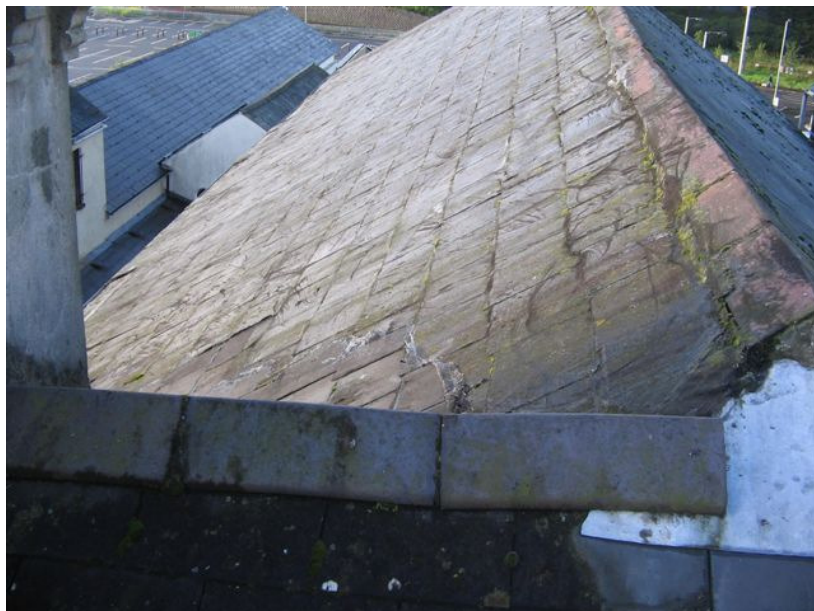
Photo 39 – Roof to rear extension

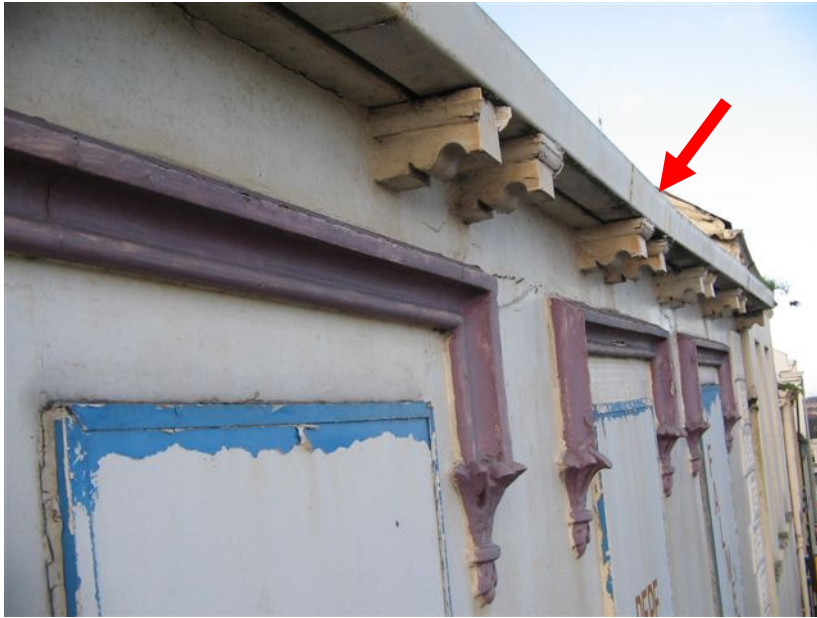
Photo 40 – Unevenness in gutter line

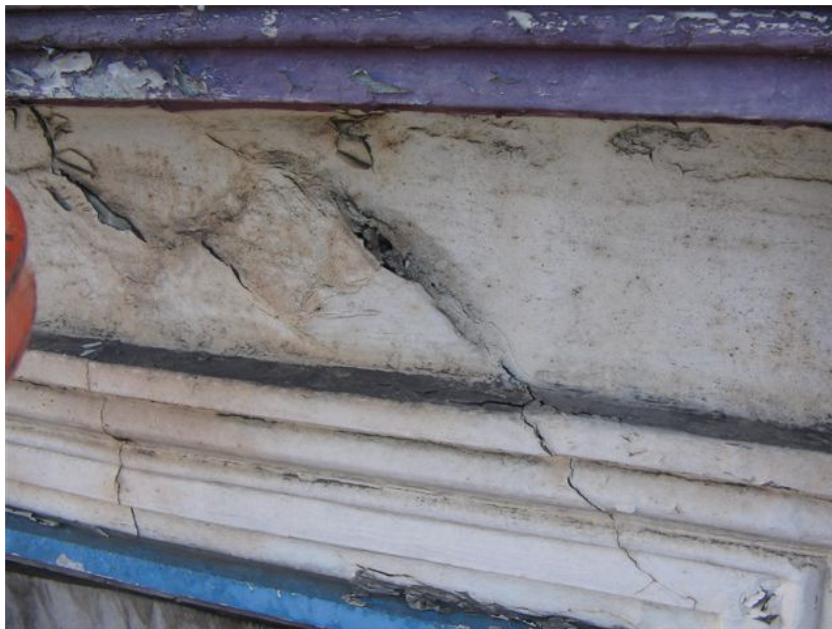
Photo 41 – Boasting on render

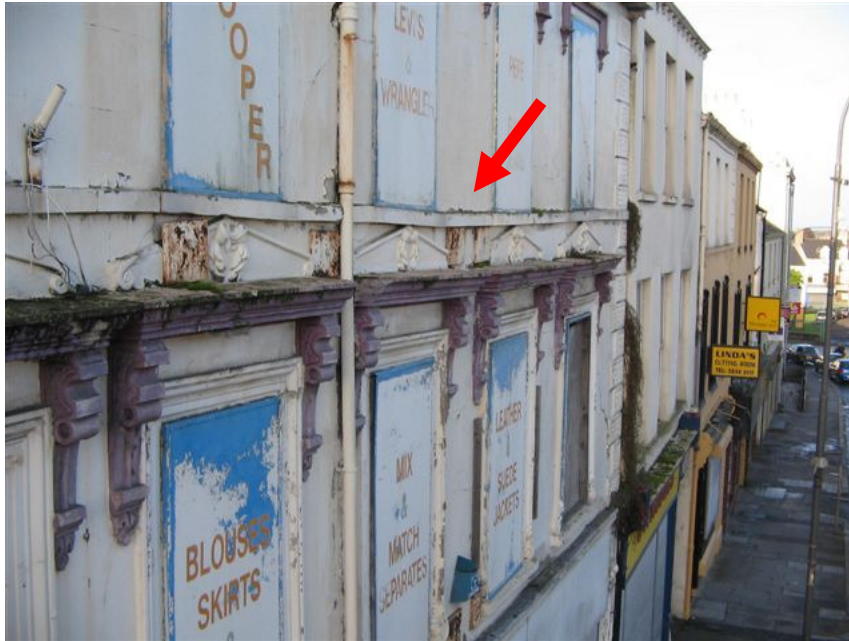
Photo 42 – Unevenness in 2<sup>nd</sup> floor sills

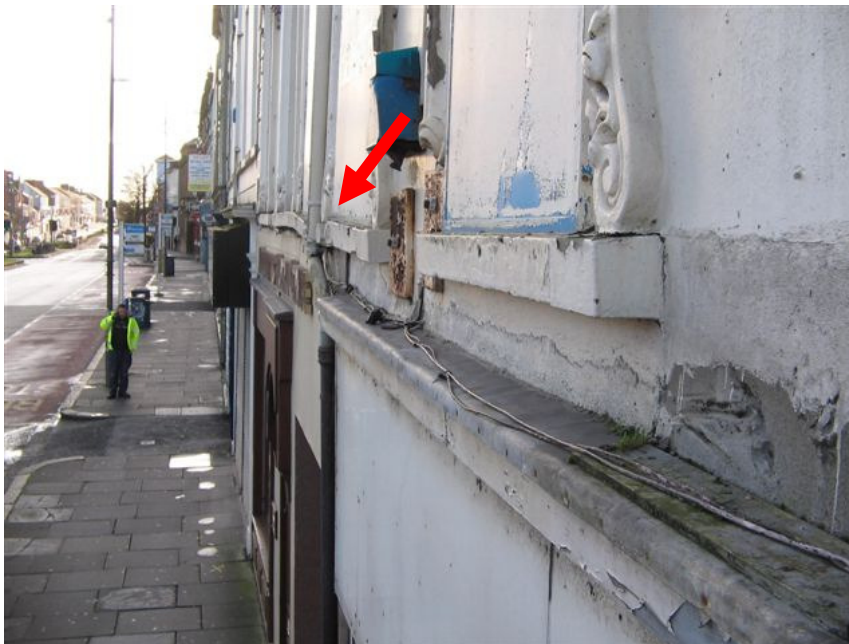
Photo 43 – Unevenness in 1<sup>st</sup> floor sills

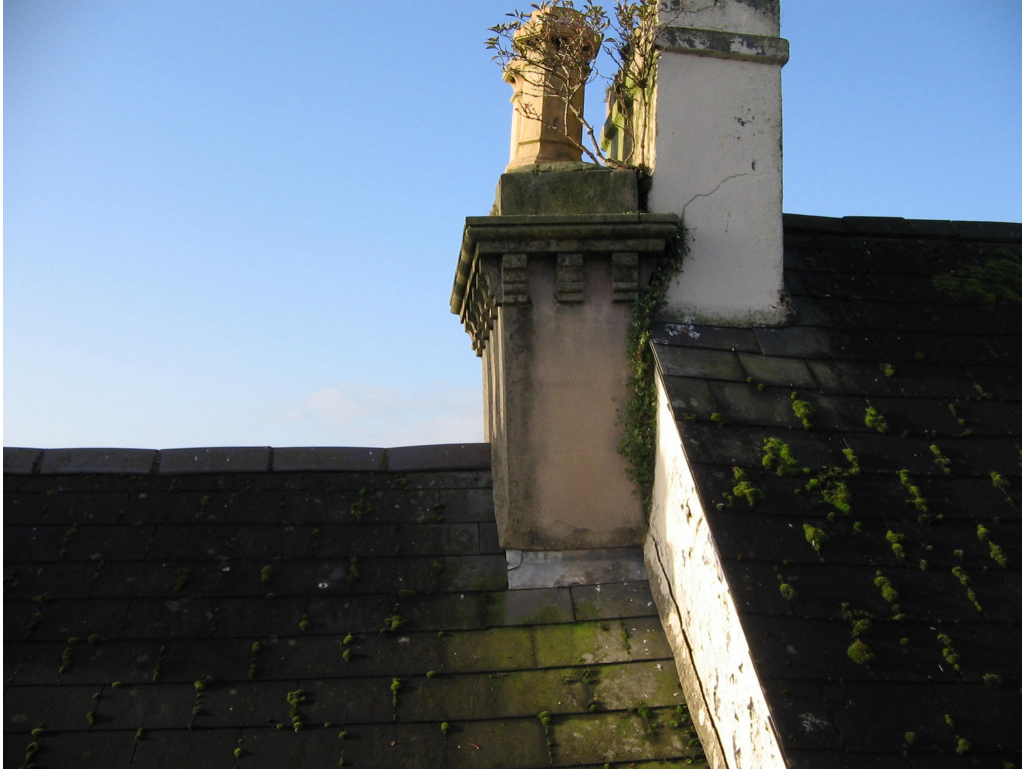
Photo 44 – Disruption to chimney and party wall at roof juncture.
