### 4.3.1 7 North Street

Round 1 Reference	194
Priority	Reserve
Address	7 North Street, Lurgan
Existing Use	Residential
Occupancy	Vacant
Date of Construction	c 1860
Architect	Not known
Heritage Merit	Streetscape, local interest
Listed Building Status	Not Listed
Capital Cost	£192,685

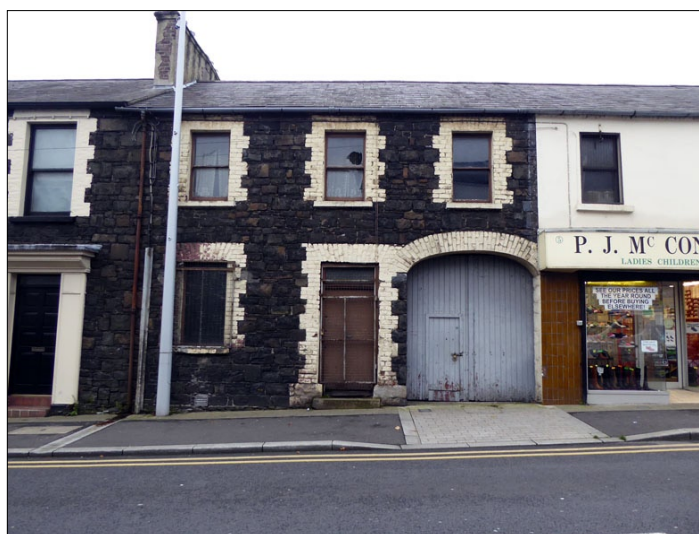
Structure appears to be sound when viewed from exterior, however owner indicated building in extremely poor condition internally. No evidence of roof structure sagging, small single storey return to rear in poor condition and derelict.

- Chimneys - All chimneys removed.
- Roof - Pitched natural slate roof with clay ridges. Some movement evident to rear. Some isolated slipped and broken slates otherwise in reasonable condition.

- Rainwater Goods - Replacement half-round metal gutters inappropriate. Extensive corrosion to eaves brackets, downpipe to left extensively corroded and in poor condition. Shoe missing to base of downpipe.

- External Walling - Coursed basalt walling with painted brick dressings. Minor patch repairs to pointing. Some areas of pointing missing and eroded otherwise in reasonable condition.

- Dressings - Painted brick dressings, some spalling of brickwork particularly around door and ground floor window otherwise reasonable condition.
- Windows - Painted timber framed fixed casement light to ground floor with Georgian wired glass inappropriate. Painted timber one-over-one sliding sashes to first floor. All in poor decorative order. Some evidence of decay. Meeting rails in central window has inappropriately replaced timber section. 1 no. pane of glass broken.

- Doors - Painted square-headed timber sheeted door with obscured glazed fanlight above. Inappropriate and in poor condition. Painted vertically sheeted timber gate with wicket gate to carriage-arch. Poor decorative order. Some replacement sections. Evidence of timber decay to base of door. Inappropriate ironmongery.

- Miscellaneous - Extensive surface-fixed cabling and conduits especially to eaves level. Metal grilles inserted over openings. All heavily corroded. Granite entrance step well-worn but in reasonable condition. Sills heavily worn especially that to ground floor window heavily spalled and friable.

- Structural - Remove vegetation from return. Grub-up existing floor structure and install new insulated concrete ground floor. Install new timber first floor structure. Allow for underpinning of existing foundations. Demolish existing return and rebuild in concrete blockwork with lime-based rendered finish.

- Chimneys - Reinstall red brick corbelled chimneys to party walls. Install clay pots.
- Roof - Strip existing slate roof and allow for repair of existing roof timbers to main roof (allow for say 40%); allow for new timber roof structure to rear return. Reslate front roof slope using salvaged natural slates, reslate rear slope and return roof with new Welsh natural slate.

- Rainwater Goods - Remove vegetation and replace existing gutters and downpipes in cast-iron, provide new fixings.
- External walls - Remove vegetation from rear elevation and return. Remove existing render over carriage-arch. Repoint existing stonework. Remove paint from window and door surrounds and carry out brick repairs (say 40 no).

- Entrance - Remove existing timber door and frame and provide new four-panelled timber door with glazed fanlight over.
- Windows - Remove, repair and reinstall all windows including draught-proofing, allow for new painted timber one-over-one sliding sash windows to front and rear. Provide new internal linings, architraves and sills to traditional profile. Repair stone sills.

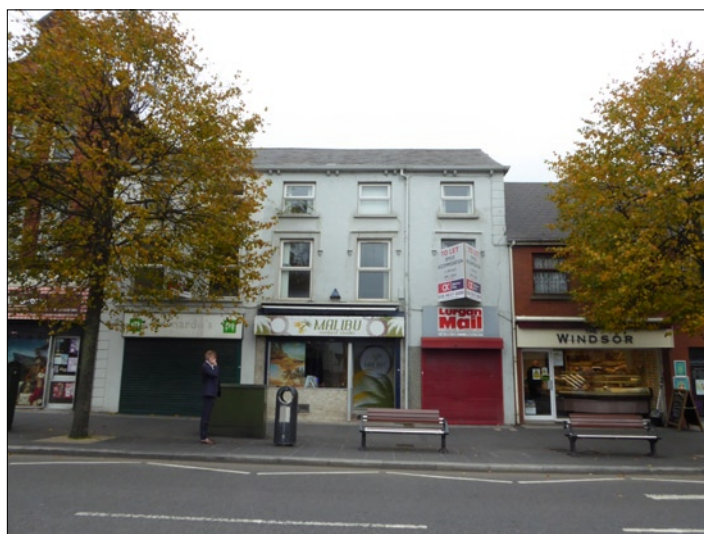
- Structure - Some sagging of roof between load-bearing walls requires further investigation. Cracking evident between window openings on street elevation.

- Chimneys - Chimneys completely removed.
- Roof - Pitched natural slate roof with clay ridge tiles; artificial slate to rear slope. Some isolated slipped and missing slates otherwise reasonable condition.

- Rainwater goods - Moulded aluminium gutters and round down-pipes on paired corbels. Vegetation growth. Poor decorative order otherwise reasonable condition.

- External walls - Painted block-marked lime-render. Evidence of extensive bubbling and cracking. Poor condition. Patch repair at junction with adjacent property at right is smooth render down to ground floor.

- Dressings - Decorative hood-moulds with decorative stop ends to first floor windows. Significant cracking.
- Windows - Replacement PVC casements inappropriate.

- Structure - Allow for crack stitching to street elevation.
- Chimneys - Reinstall brick corbelled chimney to right-hand gable and central loadbearing wall, with smooth lime-based render finish. Install decorative clay pots.

- Roof - Remove moss growth. Strip existing slates and investigate roof structure and allow for repair of defective timbers (allow for say 25%). Reslate using new Welsh natural slate. Provide thermal insulation at rafter level.

- Rainwater goods - Remove and replace with cast iron.
- External walls - Strip and re-render using wood float lime-based render; blockmarked finish. Repair and reinstall decorative hood-mouldings to match existing historic profile. Repair paired corbelled eaves course.

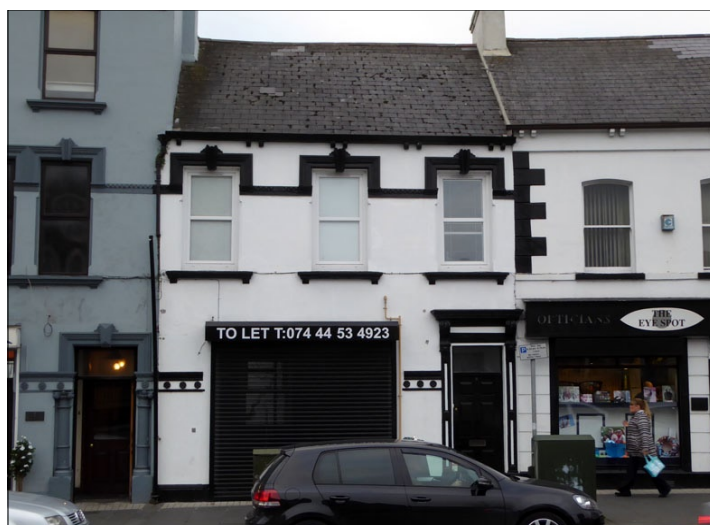
- Roof - Fibre-cement slate, poor condition.
- Rainwater goods - Moulded cast iron, in poor condition.
- Render - Reasonable condition.
- Dressings - Reasonable condition.
- Windows - Inappropriate uPVC casements to first floor.
- Entrance door - Reasonable condition.
- Shopfront - Inappropriate roller shutter concealing modern shopfront.

- Roof - Strip and re-slate using new Welsh natural slate. Provide thermal insulation.
- Rainwater goods - Replace with new moulded cast-iron gutters and new circular cast-iron downpipe.

- First floor windows - Replace existing with new one/one timber sliding sashes; draft-proofed throughout. Make good internal linings, sills and plaster.

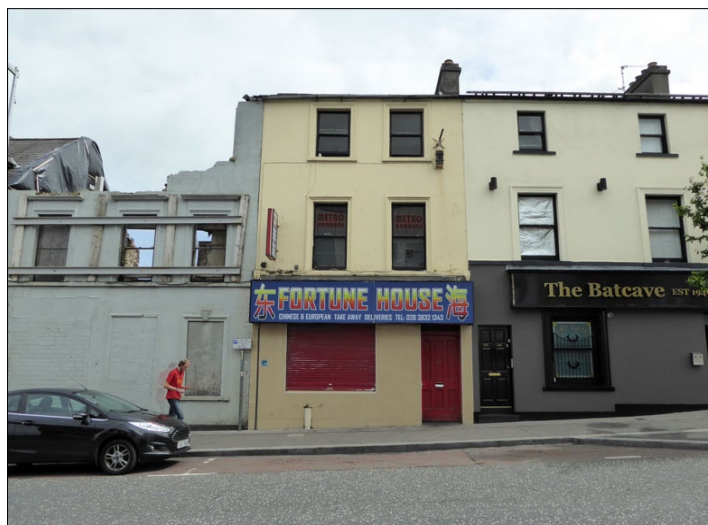
- Chimneys - Corbelled rendered chimney to right party wall; that to left removed. Clay pots. Reasonable condition.
- Roof - Roof not clear from street however appears to be pitched artificial slate with clay ridge tiles. In reasonable condition.

- Rainwater goods - Replacement half-round uPVC rainwater goods in poor condition and inappropriate.
- External walls - Painted render. Extensive cracking, especially at window openings, poor decorative order.

- Windows - Replacement painted one-over-one sliding sash windows, reasonable condition.
- Shopfront - uPVC framed display window, roller shutter and oversized illuminated fascia inappropriate.

- Entrance - Replacement timber panelled entrance door in reasonable condition. Inappropriate ironmongery.
- Miscellaneous - Extensive surface fixed cabling over fascia.

- Structural work - Requires further investigation to ensure stability given condition of adjoining building.
- Chimney - Reinstate corbelled chimney to left party wall; wood float lime-based render finish.

- Roof - Strip existing and re-slate using new natural Welsh slate. Provide thermal insulation.
- Rainwater goods - Remove and replace existing rainwater goods in cast iron. New fixings.

- External walls - Strip and re-render using wood float lime-based render with blockmarked finish. Reinstate and repair decorative hood-mouldings to window openings.

- Windows - Install draught-proofing to existing sash windows. Repair existing stone sills.
- Shopfront - Remove existing fascia, hanging signage and roller shutter. Install new timber framed decorative display window with appropriately scaled fascia on console brackets over, new toughened plate glass glazing.

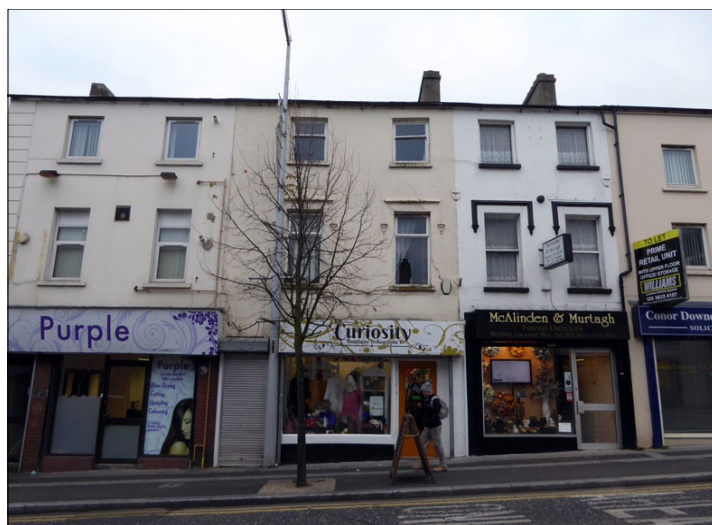
- Chimneys - Corbelled rendered chimney to right party wall; that to left removed. Clay pots. Reasonable condition.
- Roof - Roof not clear from street however appears to be pitched natural slate with terracotta ridge tiles. In reasonable condition.

- Rainwater goods - Half-round cast-iron rainwater goods in poor decorative order.
- External walls - Painted block marked lime render. Extensive cracking and bubbling of paint. Poor condition.

- Windows - Replacement timber casement windows at first floor. Inappropriate otherwise reasonable condition. Original one-over-one timber sliding sashes retained to second floor. Poor decorative order. Misaligned other appear in reasonable condition. Painted stone sills retained throughout.

- Shopfront - Replacement timber framed shopfront with roller shutter and printed signage. Inappropriate. Otherwise in reasonable condition.
- Entrance - Access to first floor to left of shopfront. Inappropriate roller shutter over.

- Miscellaneous - Single storey return and flat roofed extension to rear. Rear elevation is unpainted rendered. All openings built up. Enclosed yard to rear. Unfinished and in poor condition.

- Structure - Evidence of structural movement in front façade. Extensive cracking to windows at right suggest structural displacement. Elevation bowed out to right of street frontage above shop door.

- Structural work - Requires further investigation of street façade. Allow for structural tying of wall back to floors and new steelwork to support masonry above shopfront opening. Demolish existing single-storey extension to rear and replace with new to include new insulated concrete floor structure, insulated masonry cavity walls and new timber roof structure.

- Chimney - Strip existing render and replace with roughcast lime-based render. Reinstate brick chimney to left gable wall to match existing with roughcast lime-based render finish. Install new clay pots.

- Roof - Strip existing. Investigate roof structure and allow for repair of defective timbers (say 30%). Re-slate using existing slates where possible. Use new Welsh slates for rear pitch. Provide thermal insulation.
