### 4.3.1 7 North Street

Round 1 Reference	194
Priority	Reserve
Address	7 North Street, Lurgan
Existing Use	Residential
Occupancy	Vacant
Date of Construction	c 1860
Architect	Not known
Heritage Merit	Streetscape, local interest
Listed Building Status	Not Listed
Capital Cost	£192,685

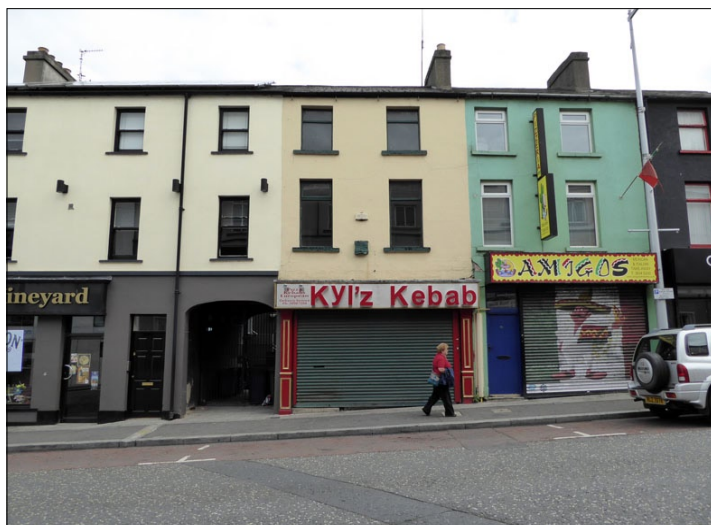
### 4.3.6 33 William Street

- Chimneys - Corbelled rough cast rendered chimney to right gable with clay pots. Evidence of patch repairs otherwise reasonable condition.
- Roof - Artificial slate roof with terracotta ridges. Inappropriate. Extensive moss growth. Isolated slipped slates. Otherwise reasonable condition.

- Rainwater goods - uPVC rainwater goods inappropriate. Joint failure. Minor damage to brick corbels behind.
- External walls - Extensive cracking to painted block marked lime render especially around openings. Cement render patch repair above shopfront fascia. Extensive vegetation growth to rear elevation, areas of defective pointing and inappropriate cement pointing repairs.

- Shopfront - Replacement timber shopfront surround with uPVC shopfront windows and entrance door. Timber surround shows sign of decay to base. Damage to fascia surround. Roller shutters concealed behind timber fascia. Inappropriate. Signage and lighting inappropriate.

- Windows - Painted timber casement windows. Inappropriate otherwise reasonable condition. Extensive paint flaking to stone sills.
- Miscellaneous - Surface-fixed cabling to illuminated hanging sign. Concrete step to entrance.

- Chimneys - Strip existing render and replace with roughcast lime-based render. Reinstate brick chimney to left gable wall to match existing with roughcast lime-based render finish. Install new clay pots.

- Roof - Strip existing artificial slates. Investigate roof structure and allow for repair of defective timbers (say 15%). Reslate using natural welsh slate. Provide thermal insulation.

- Rainwater goods - Remove and replace with cast-iron.
- External walls - Remove vegetation growth. Strip and re-render using wood float lime-based render with blockmarked finish. Roughcast render to rear.

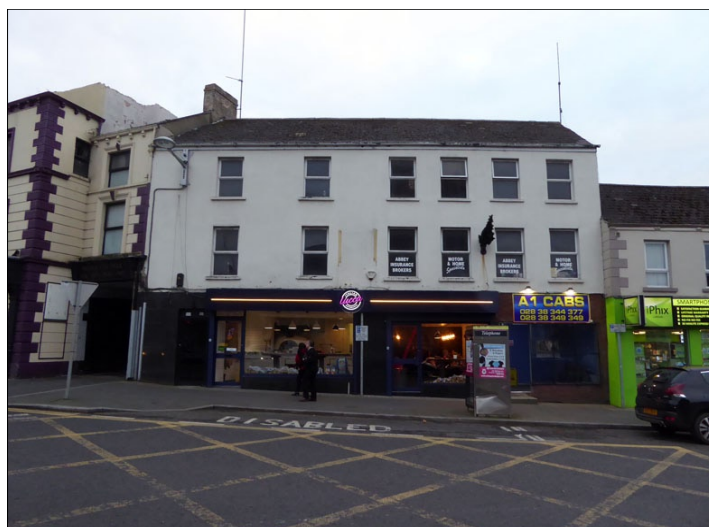
- Chimneys – Single rendered chimney to left-hand side in poor decorative order. Other chimneys removed.
- Roof - Inappropriate replacement artificial slate, in reasonable condition.
- Rainwater goods - Inappropriate replacement painted extruded aluminium gutter.
- Render - Appears to be inappropriate cementitious render in poor decorative order.
- Windows - Inappropriate uPVC casements.
- Shopfronts - Inappropriate modern shopfronts with aluminium roller shutters.
- Modernised to ground floor as 3 no. retail units, 1 potentially vacant. Appears to be vacant to upper floors, not accessible at time of survey.
- Miscellaneous - Windows largely boarded up or removed to rear. Replacement corrugated metal roof to two-storey rear extension. Original cast-iron rainwater goods to rear, in poor condition.

- Chimneys – Rebuild red brick chimneys with corbelled detail to gable walls and centrally; wood float lime-based render finish. Install new clay pots.
- Roof – Strip and reslate using new Welsh natural slate. Provide thermal insulation.
- Rainwater goods – Replace rainwater goods in cast iron.
- Render – Strip and rerender using wood float lime-based render with blockmarked finish.

- Windows – Replace existing windows with new 1/1 timber sliding sashes to first and second floor; draught-proofing to be included throughout. Make good existing internal architraves, linings, sills and plaster.

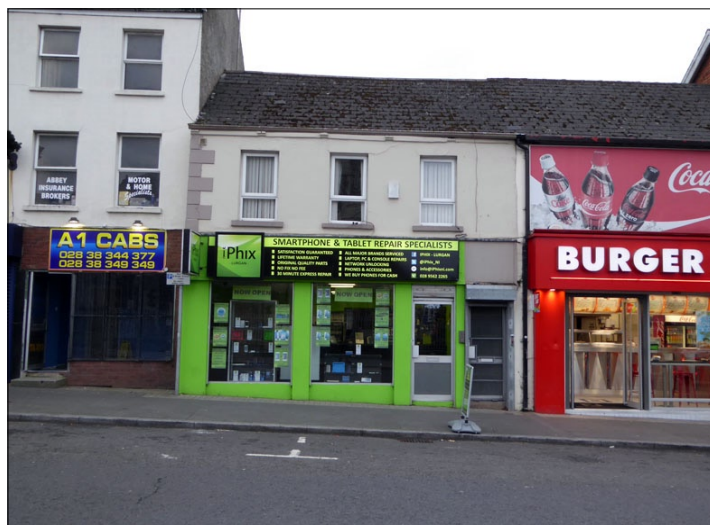
- Chimney – Chimneys missing.
- Roof – Artificial slate with patch repairs, inappropriate, poor condition.
- Gutters – Replacement gutters inappropriate, otherwise reasonable condition.
- External render – Poor condition.
- First floor windows – Replacement casement windows inappropriate, otherwise reasonable condition.
- Ground floor shopfront – Inappropriate.
- Ground floor entrance – Inappropriate

- Roof – Strip and reslate using new Welsh natural slate. Provide thermal insulation.
- Rainwater goods – Replace rainwater goods with moulded cast iron.

- Render – Remove existing render and re-render using wood float lime-based render with blockmarked finish.
- Windows – Replace existing windows with new one-over-one timber sliding sash units complete; draught-proofing to be provided throughout. Make good existing internal architraves, linings, sills and plaster.

- Entrance – Remove existing entrance door and frame and replace with new timber panelled entrance door

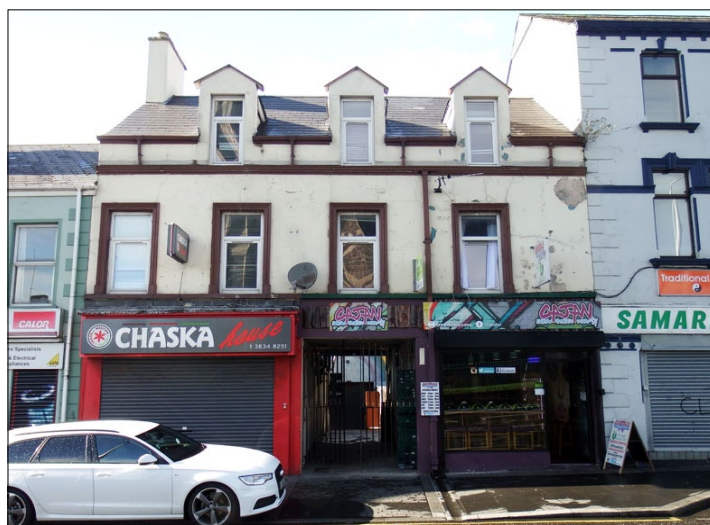
### 4.3.9 14-15 Church Place

- Chimneys - Replacement rendered chimney, inappropriate, with yellow clay pots, also inappropriate.
- Roof - Inappropriate replacement artificial slate roof in reasonable condition.
- Render - Appears to be inappropriate cementitious render with widespread crazing and cracking, poor decorative order.
- Windows - Inappropriate uPVC casements. Moulded decorative render surrounds in reasonable condition.
- Shopfronts - Inappropriate modern shopfronts.
- Rainwater goods - Extruded painted metal rainwater goods, inappropriate, otherwise reasonable condition.
- Miscellaneous - Inappropriate extensions to rear, not visible from street. Inappropriately altered carriage arch to centre of ground floor.
- Interior - Modernised to ground floor, no original detailing remains. No access to upper floors at time of survey

- Chimneys – Rebuild red brick chimneys with corbelled detail to left gable wall; wood float lime-based render finish. Install new clay pots.
- Roof – Strip and reslate using new Welsh natural slate. Provide thermal insulation.
- Rainwater goods – Replace rainwater goods in cast iron.
- Render – Strip and re-render using wood float lime-based render with blockmarked finish.

- Windows – Replace existing windows with new 1/1 timber sliding sashes to first and second floor; draught-proofing to be included throughout. Make good existing internal architraves, linings, sills and plaster.

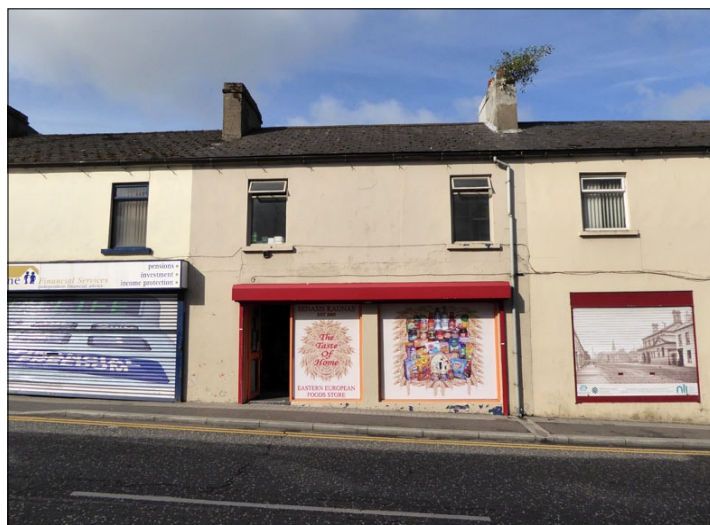
### 4.3.10 6 William Street

- Chimneys - Corbelled rough cast rendered chimneys to party walls. Vegetation growth; patch repairs to render, damage to corbelled detailing. Otherwise reasonable condition.
- Roof - Natural slate roofing. Moss growth, otherwise reasonable condition.
- Rainwater goods - uPVC half round gutters inappropriate otherwise reasonable condition.
- External walls - Painted block marked lime rendered walling to street. Poor decorative order. Some patch repairs. Otherwise reasonable condition.
- Windows - Painted timber casements inappropriate otherwise reasonable condition.
- Shopfront - Replacement shopfront, roller shutter and signage inappropriate.
- Miscellaneous - Surface-fixed cabling. Enclosed yard to rear with no access.

- Chimneys - Remove vegetation. Strip and re-render using rough-cast lime render. Install replacement pots to both chimneys.
- Roof - Carry out minor slating repairs (allow for say 10 slates).
- Rainwater Goods - Remove and replace with cast-iron gutters and downpipes.
- Render - Strip and re-render using wood float lime-based mortar, blockmarked to front and smooth to rear. Redecorate.
- Windows - New one-over-one sliding sashes throughout. Draught-proofing to be included. Make good existing internal sills and wall plaster.
- Shopfronts - Remove existing shopfront, roller shutters and fascia. Install new purpose-designed traditional shopfront, including masonry stallriser, timber fascia and cornice, timber pilasters, and timber panelled and glazed entrance door. New toughened plate glass glazing; internal shutters.

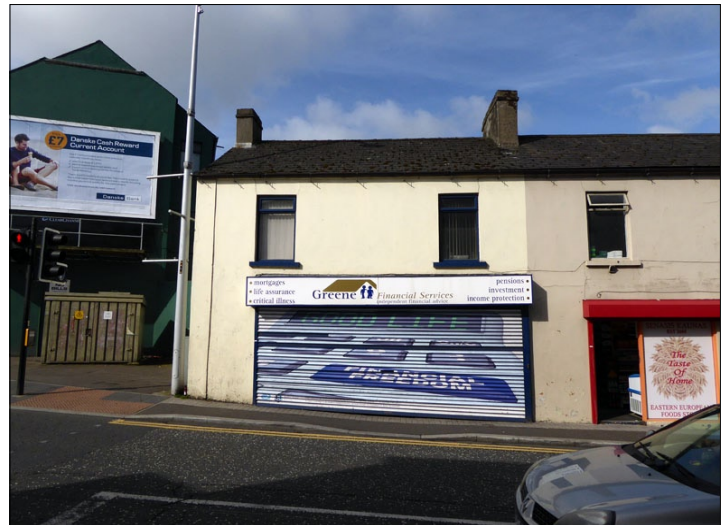
- Chimneys - Corbelled rough cast rendered chimneys to gable and party wall. Moss growth to chimneys; that to right appears to bow slightly towards left side. Some damage to corbel on chimney to right. Otherwise reasonable condition.

- Roof - Artificial slated roof inappropriate. Extensive moss growth otherwise reasonable condition.
- Rainwater goods - uPVC half round gutters inappropriate otherwise reasonable condition.

- External walls - Painted block marked lime rendered walling to street. Poor decorative order. Some patch repairs. Otherwise reasonable condition. Exposed gable to left appears to be re-rendered. In reasonable condition.

- Windows - Painted timber casements inappropriate otherwise reasonable condition.
- Shopfront - Original shopfront with central entrance retained though largely obscured by inappropriate roller shutter and modern fascia and signage. All well-worn otherwise reasonable condition.

- Entrance - Painted timber panelled glazed entrance door within recessed porch. Black and white tiling retained to threshold. All well-worn otherwise reasonable condition.

- Chimneys - Take down chimney to party wall and re-build in brick including replacement rough-cast render. Replacement pots to both chimneys, remove vegetation from chimney to gable wall.

- Roof - Strip existing artificial slates, investigate roof structure and allow for repair of defective timbers (allow for say 15%). Re-slate roof using new Welsh slate, provide thermal insulation.

- Rainwater Goods - Remove and replace with cast-iron gutters and downpipes.
- Render - Strip and re-render using wood float lime-based mortar, blockmarked to front and smooth to rear. Redecorate.

- Windows - New one-over-one sliding sashes throughout. Draught-proofing to be included. Make good existing internal sills and wall plaster.
- Shopfront - Remove, repair and reinstate existing shopfront. Remove roller shutter, new toughened-plate glass glazing and internal shutters, new timber-panelled and glazed shop door and overlight, all to traditional profile, new timber-framed plasters, cornice and fascia.

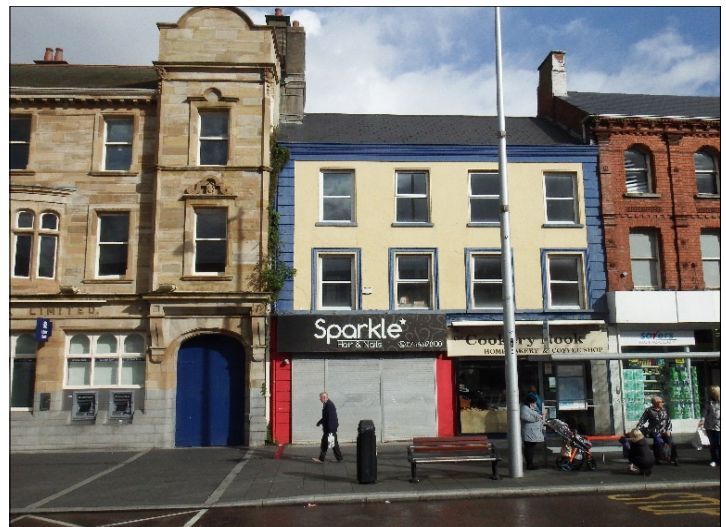
- Chimneys - Chimney to left-hand side partially re-built with some original detailing. Cementitious render to top failing with extensive cracking. Inappropriate red clay pots. Chimney to party wall removed.
- Roof - Inappropriate replacement artificial slate and inappropriate ridge tiles.
- Render - Cracking of render to window-heads and sills with some significant cracks.
- Rainwater goods - Mix of inappropriate metal and uPVC downpipes with inappropriate uPVC gutter.
- Windows - Inappropriate uPVC casements, original moulded render detailing to first floor in reasonable condition.
- Shopfront - Inappropriate uPVC signage and aluminium roller shutter.
- Miscellaneous - Significant vegetation growth to left-hand side.
- Interior - Inaccessible at time of survey.

- Roof – Strip existing and reslate in new Welsh natural slate; provide thermal insulation.
- Rainwater goods – Carry out repairs to existing cast iron rainwater goods.

- Render – Carry out minor repairs to render.
- Windows – Remove existing windows and replace with new timber 1/1 sliding sashes; draughtproofing to be provided throughout. Make good existing internal linings, sills and plaster.

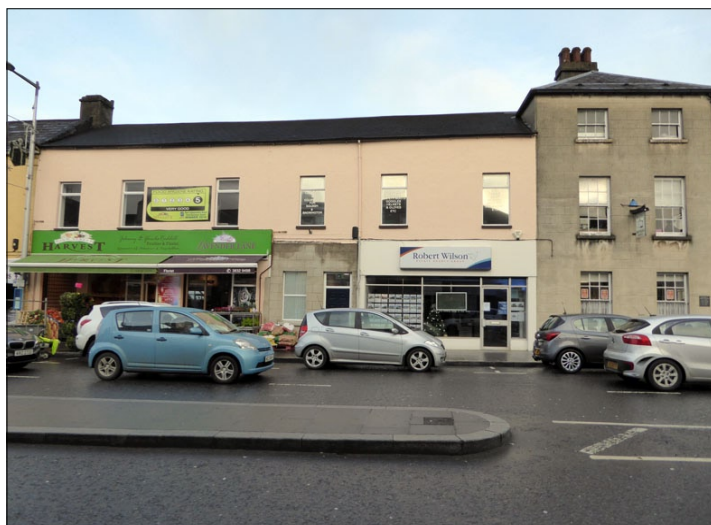
- Structure - Whilst structure appears to be sound some evidence of downward movement towards centre of elevation evident at first floor windowsills and slight misalignment evident over ground floor shopfront signage.
